Playnes Farm proposed stormwater bunds

Site Inspection & Preliminary Assessment

22 November 2024

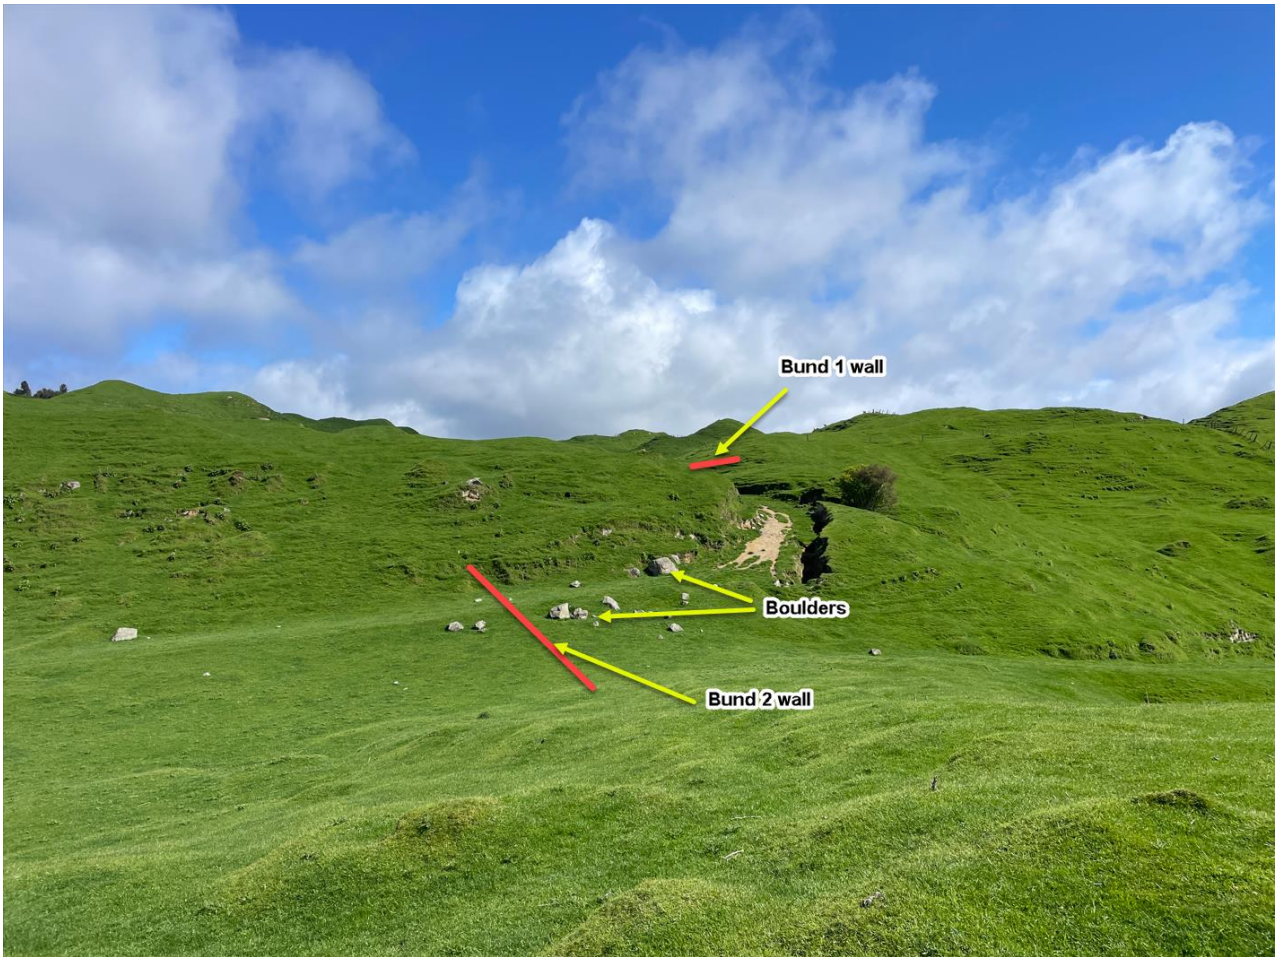
- Abundant large boulders (between 300mm and over 1m diameter) throughout the profile in the pumice sand at both bund sites. The large boulders were evident from exposures at ground / surface level and in the eroded gully and tomo features – refer Figures B.1 to B.3, B.5 and B.6 in Appendix B.

Figure B.1 View showing the relative locations of both proposed bund walls. Note large angular boulders.

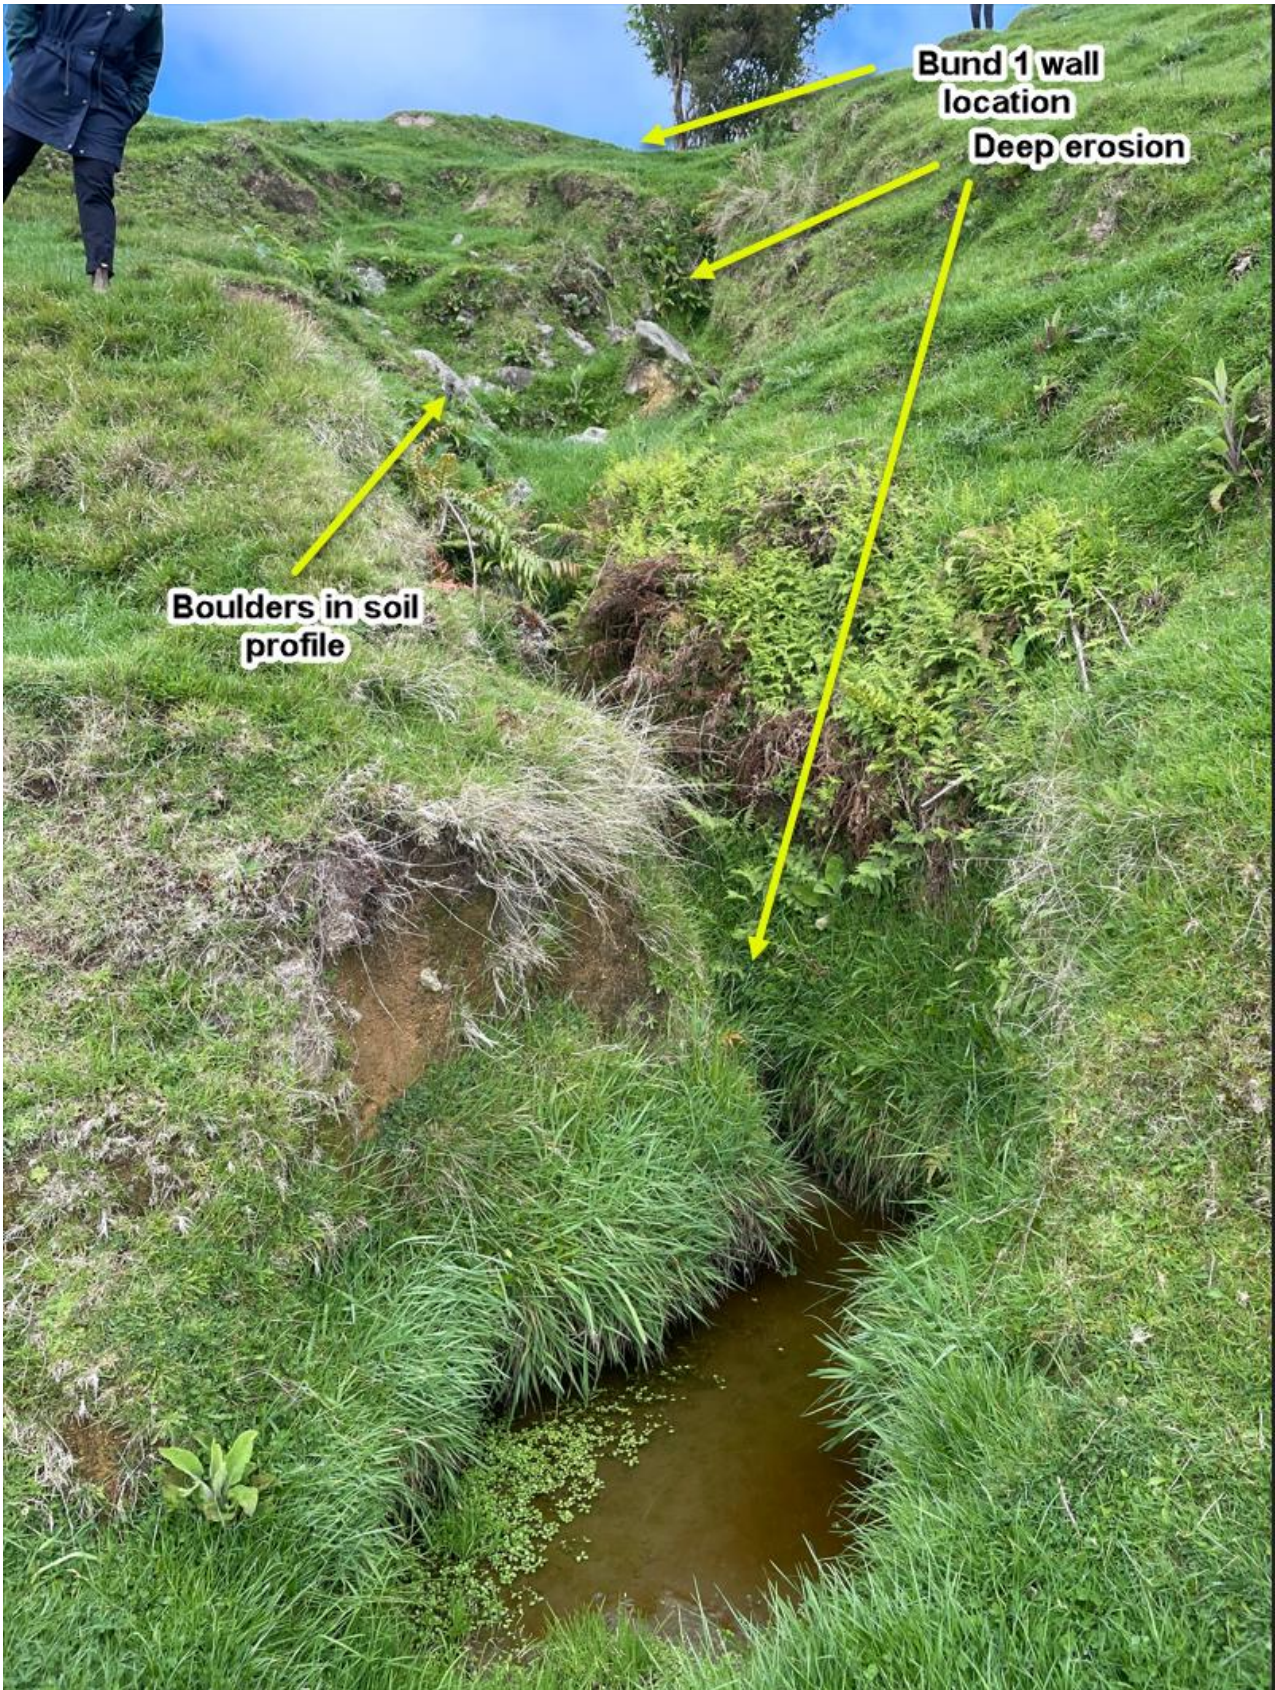
- The steep overland / subsurface flowpath and topography between the bund sites and headscarp was evident – refer Figures B.2A and B.2B. Such a high and steep hydraulic gradient (vertical fall) would indicate that during and following high intensity rainfall events, flow velocities are likely to be very high.

Figure B.2A *View upwards from downslope of the proposed bigger bund wall. Note the steep slope, deep erosional features and large angular boulders in the soil profile.*

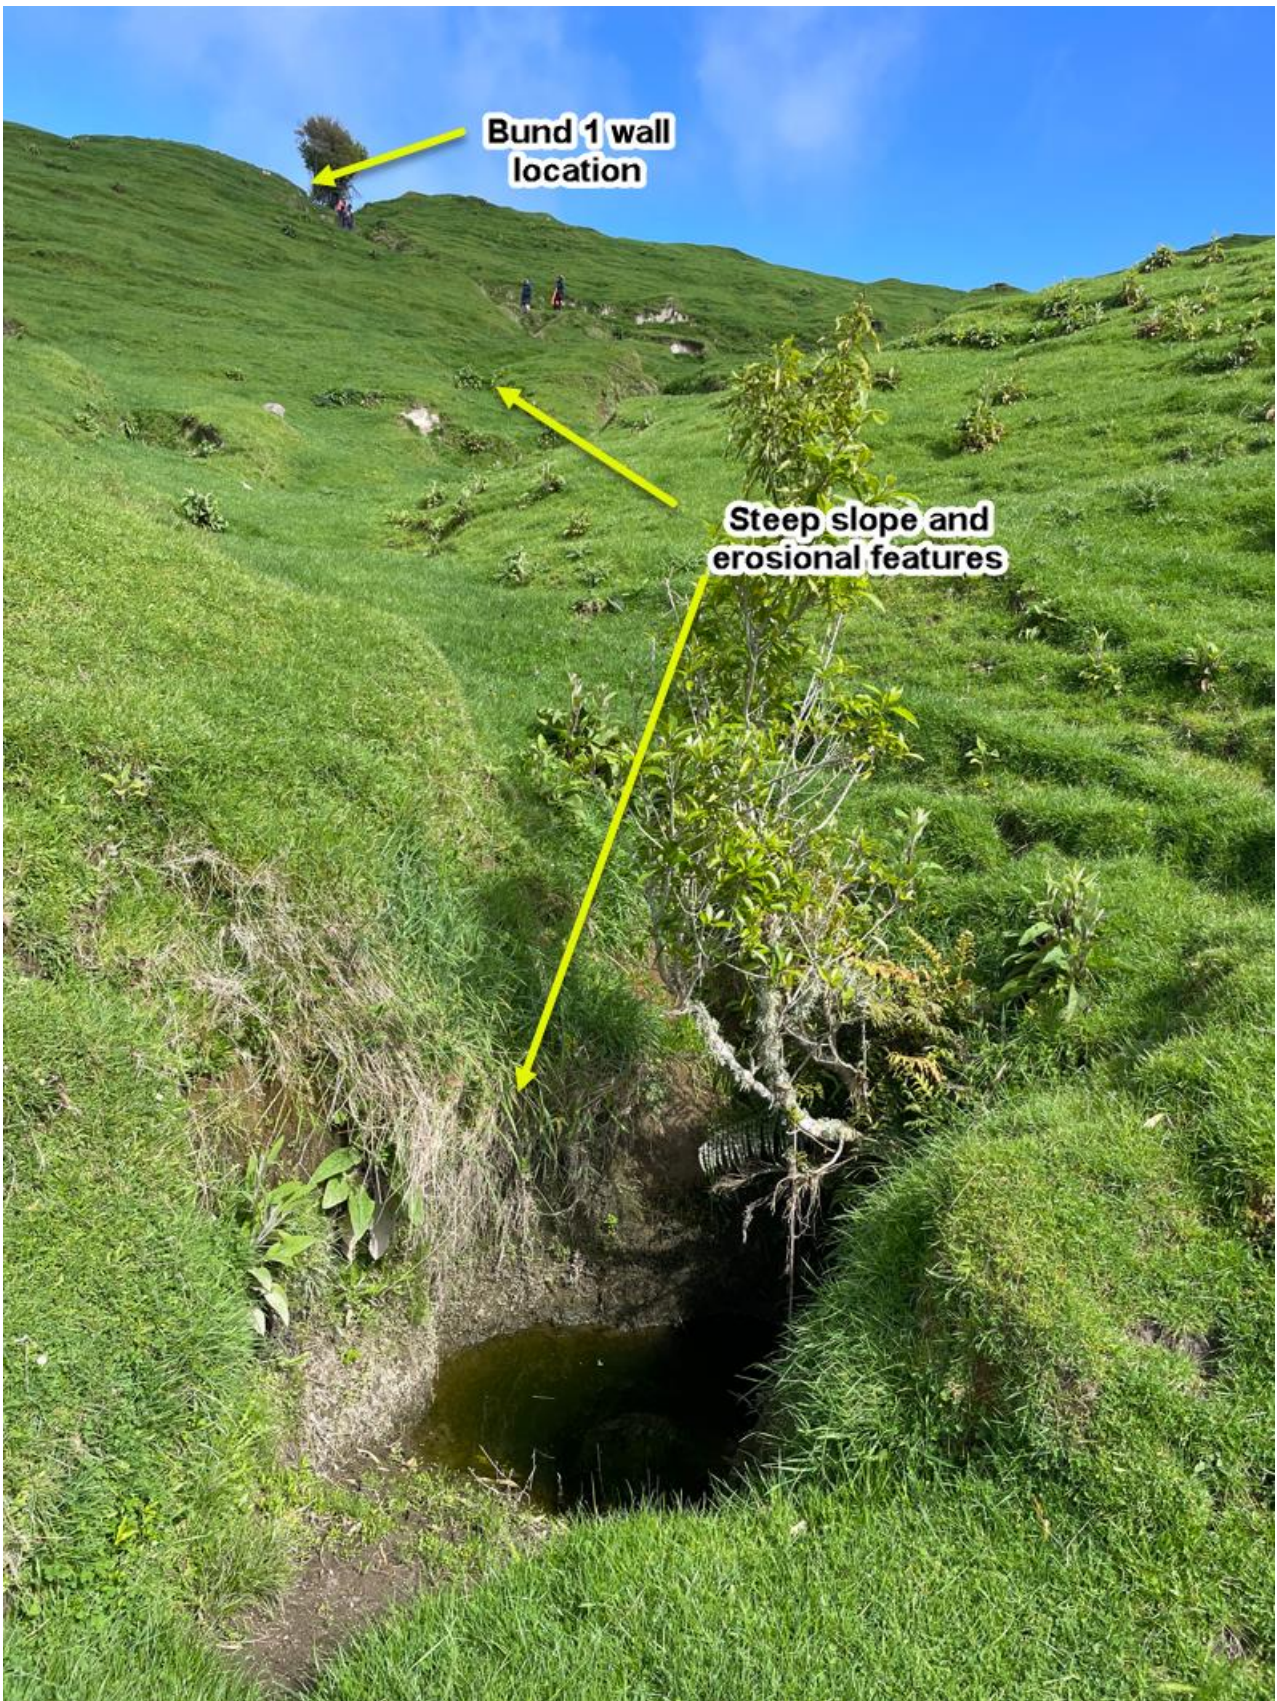
Figure B.2B View upwards from downslope of the proposed bigger bund wall. Note the steep slope and deep erosional features.

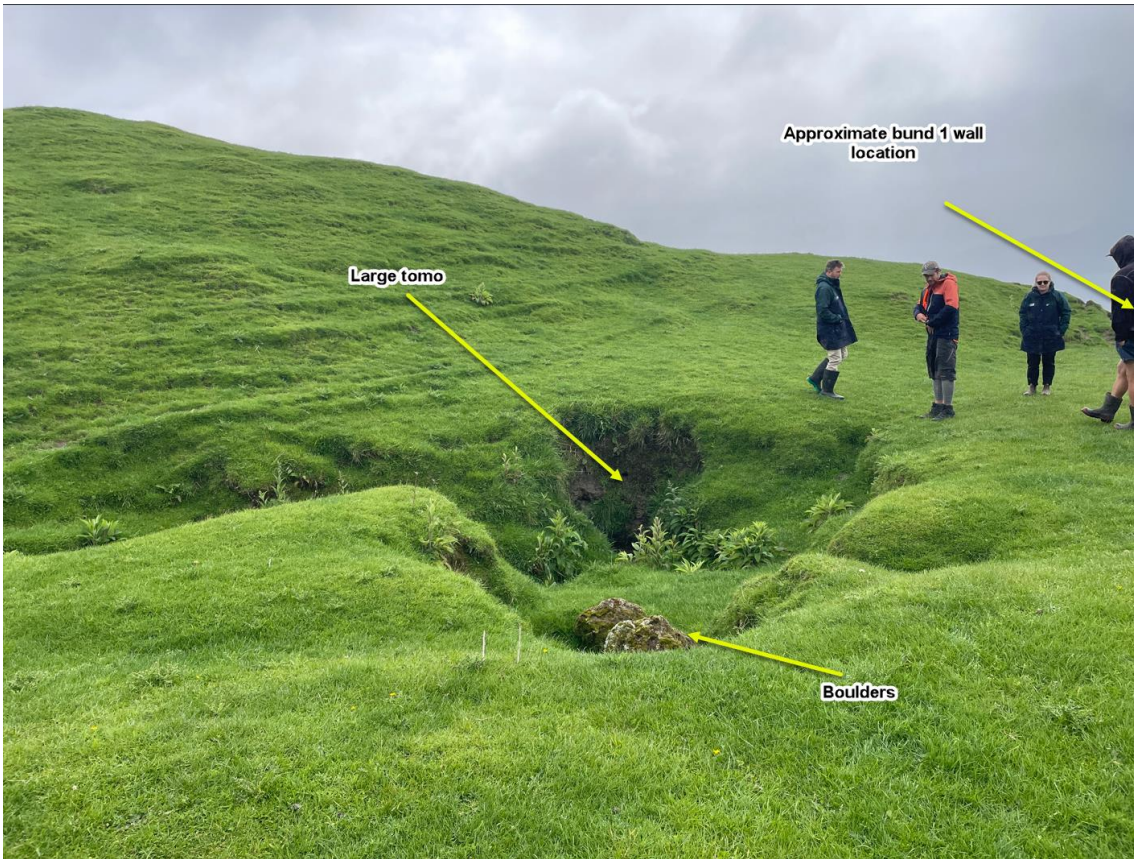
- Some tomos were able to be safely entered and inspected, however some tomos were not entered as they appeared vertical or near vertical in profile, an example of which is shown in Figure B.3 of Appendix B.

Figure B.3 Large tomo immediately upstream of the proposed location of the larger bund wall.

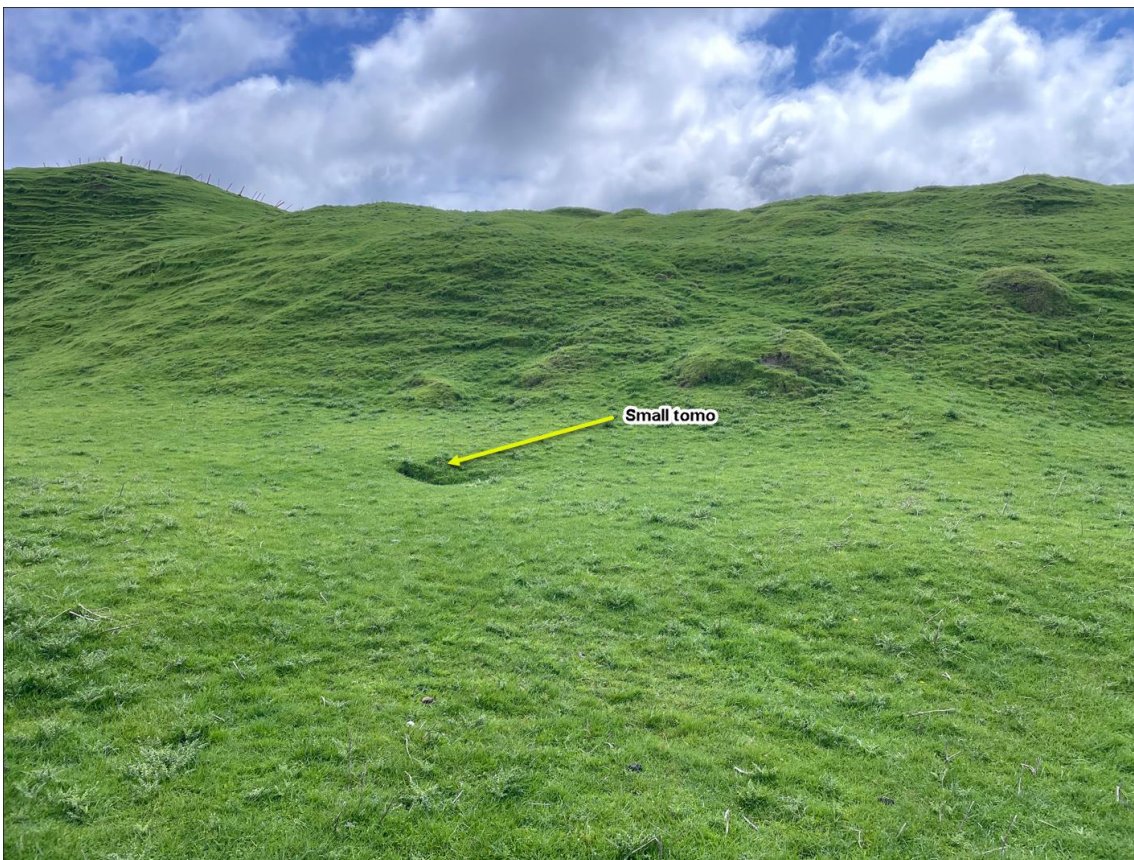
- Abundance of small tomos throughout both bund sites. This was highlighted in the GDA via review of aerial imagery but the site inspection confirmed the presence of tomos in the bunds' footprint and likely inundated areas – refer Figures B.4A, B.4B, and B.5.

Figure B.4A Example of small tomo found scattered within the catchment areas of both bunds

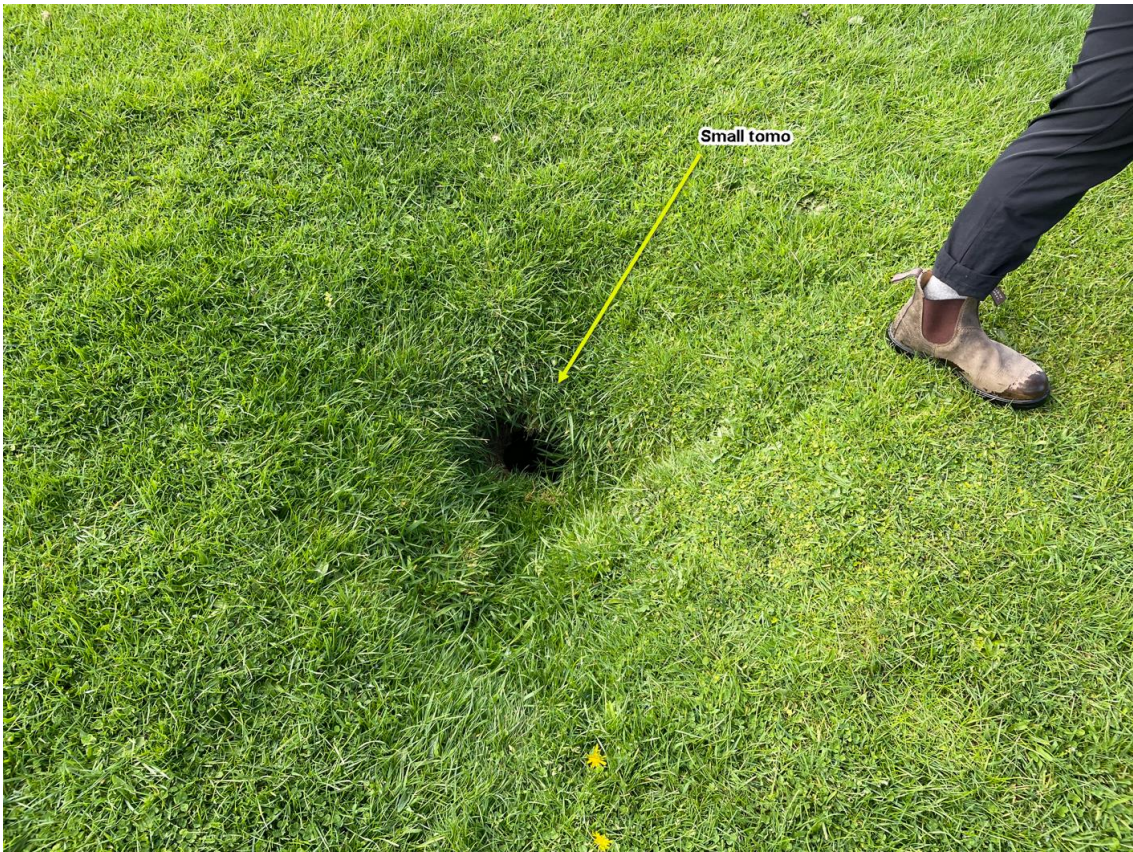
Figure B.4B Example of small tomo found scattered within the catchment areas of both bunds

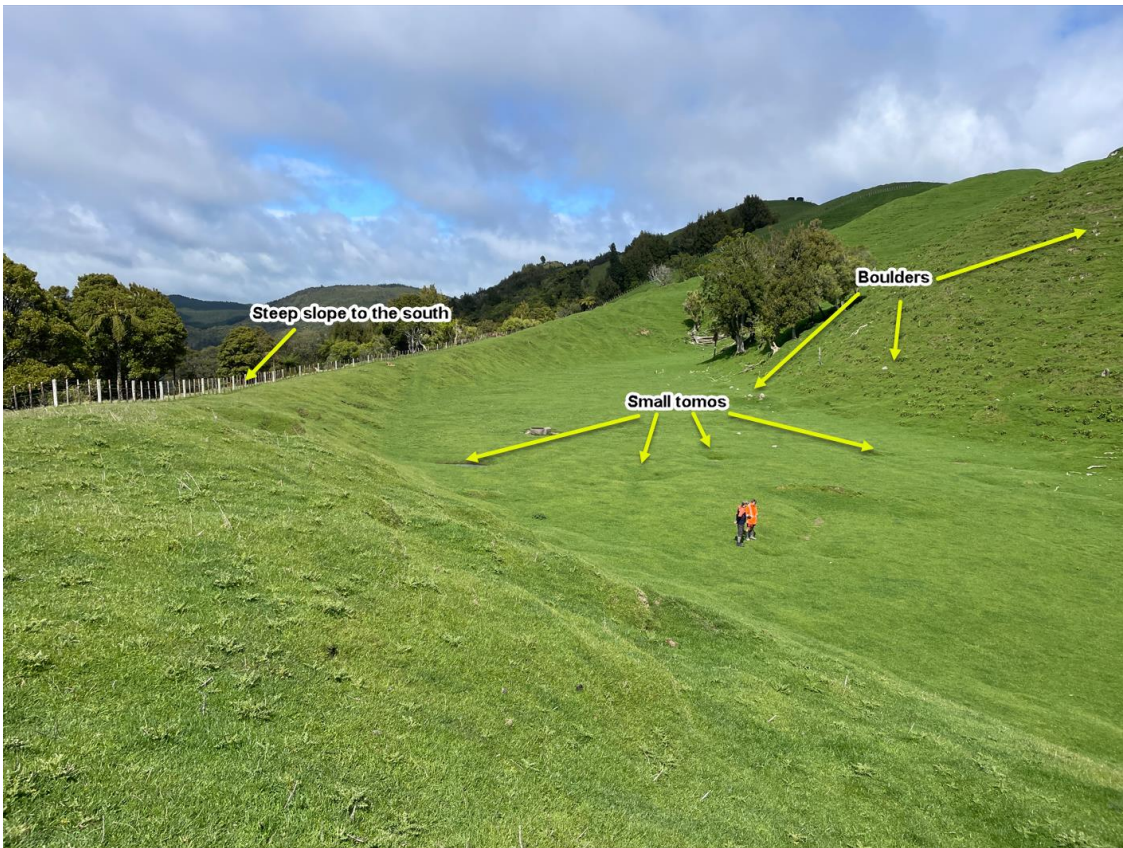
Figure B.5 View from the ridge between the smaller of the two proposed detainment dams and the steep slope towards lake Tarawera towards the southeast. Note numerous small tomos scattered around the floor of the valley.

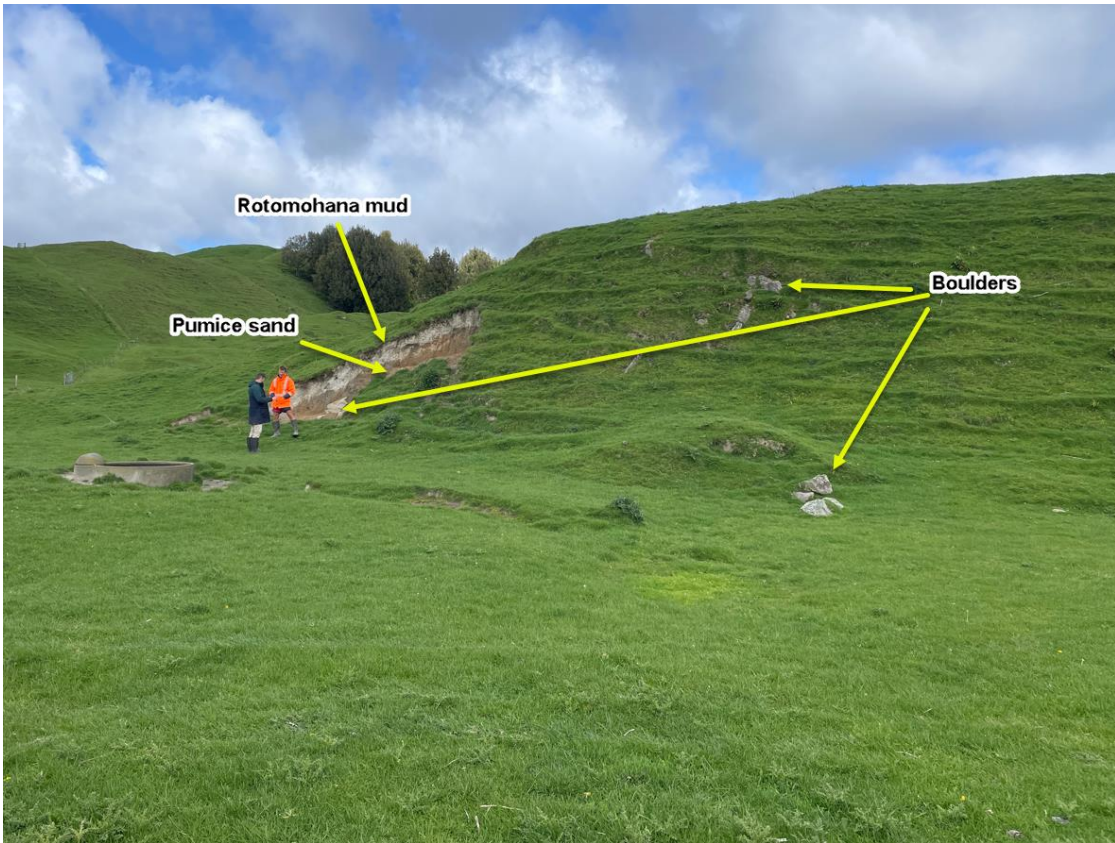
- Presence of approximately 500mm thick layer of Rotomahana mud overlying pumice sands. This unit was observed in an exposed cut face as a clayey silt – refer Figure B.6. Rotomahana mud was described (by Paul Romane of Romane Construction Ltd) as a difficult material to work with, with very low residual strength.

Figure B.6 View of small hill upstream of the larger of the two proposed bund walls. Note the Rotomohana mud (white layer between topsoil and pumice sand), also the large angular boulders.

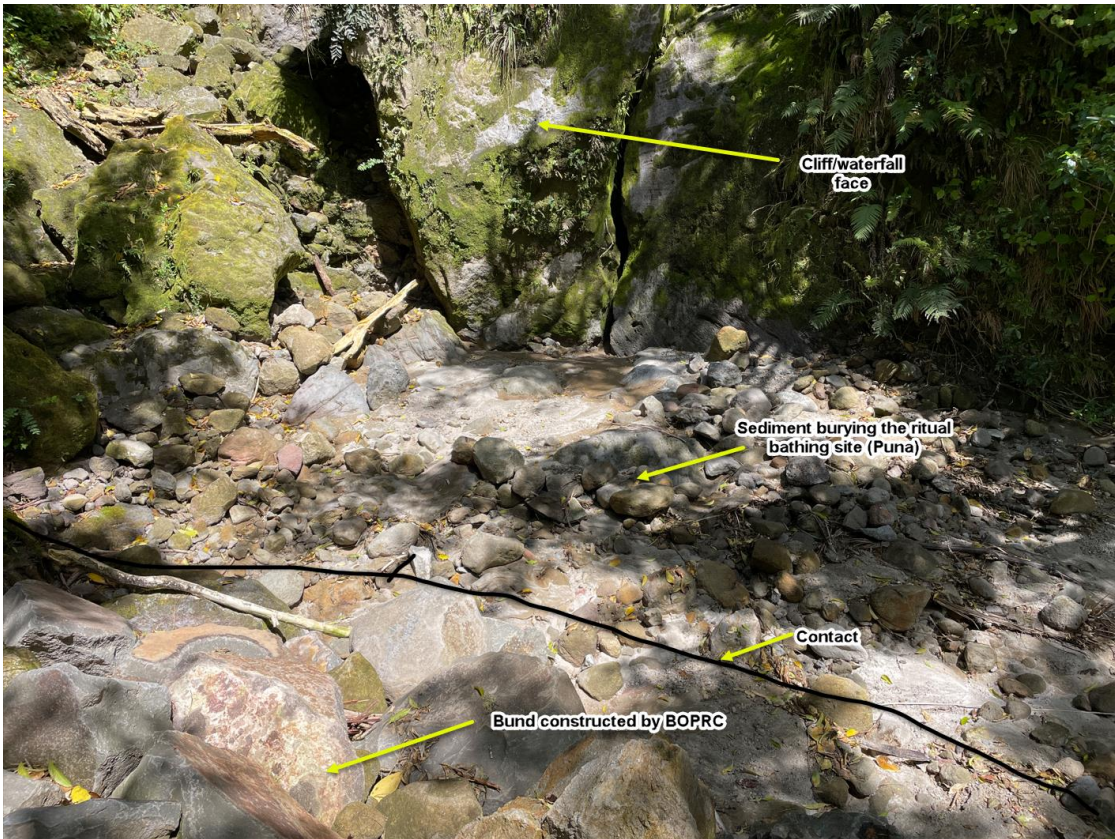
- Water in the sacred puna sites was believed to have healing properties, which was one reason for the historic use and present desire (by iwi) to restore the puna sites.
- Mixed alluvial materials within the stream bed as shown in Figure B.7. The depth of inundated alluvial material, as compared to the historic stream bed level, is unconfirmed.
- BOPRC personnel advised a rockfill weir on the true right bank had been informally constructed (date to be confirmed by BOPRC), and that no specific design and construction process was undertaken. BOPRC advised the rockfill weir (in Figure B.7) has not been witnessed during or following a storm event to assess its performance.
- It is understood that removal of inundation alluvial debris had not been undertaken within the stream bed.
- Small, surficial flow was observed daylighting and trickling into the left stream bank.

Figure B.7 View of the ritual bathing site (puna) which was buried by flood sediments. Note the bund / weir built by BOPRC to contain and convey floodwater.

Option no.	Option name	Description	Advantages	Disadvantages	Relative cost
	Figure B.7 within Appendix B) adjacent to existing bund, and undertake periodic maintenance as required to remove future mass alluvial deposits		puna sites remain but are buried. Increased flow capacity of stream / watercourse.	and not undermine / over-excavate the existing rockfill weir.
