Awa Matakana bank erosion and channel stability qualitative assessment

Short Report for Friends of Awa Matakanakana, A2E engagement

March 2024

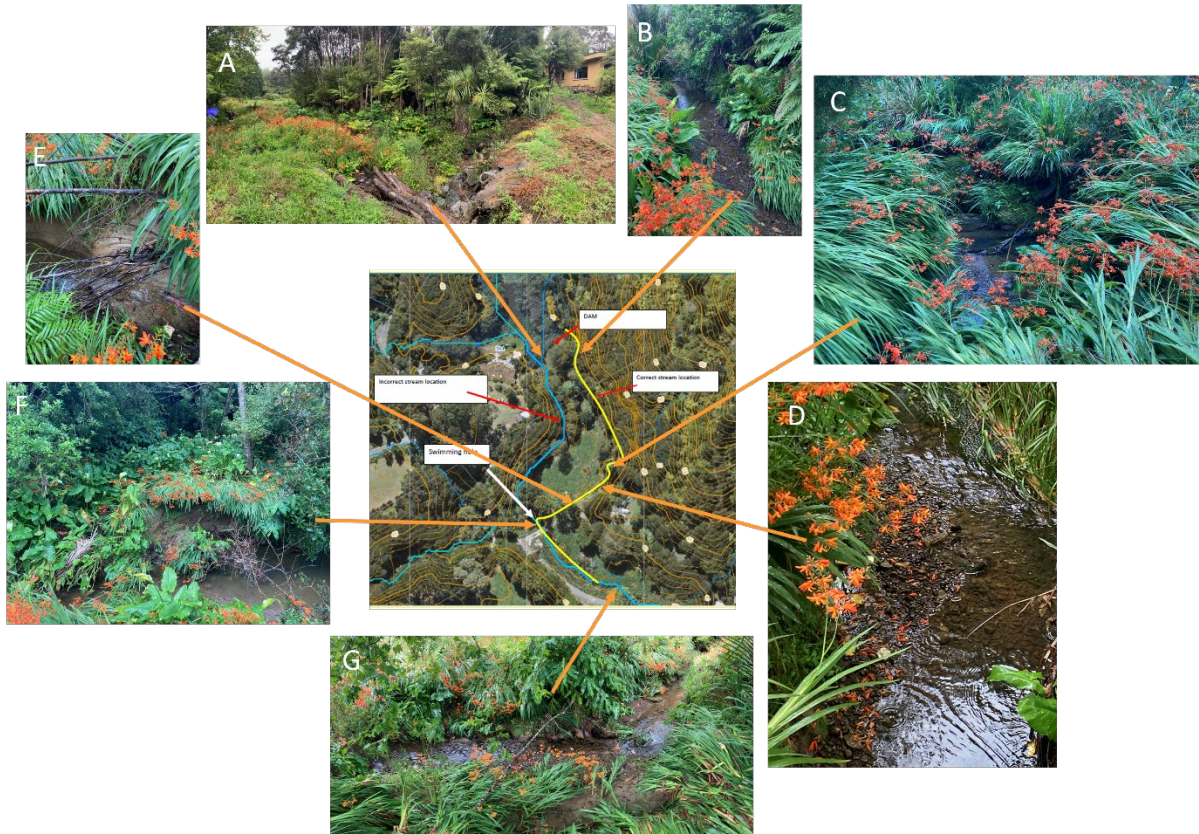
Figure 2. Site photos labelled A-G sequentially from upstream to downstream. A: head of former channel, now dammed, but still conveying flow; B: stream bed and banks in post-dam channel, noting gravelly river bed; C: Substantial vegetation and stable banks at a right-angled bend (cf. Figure 3); D: gravelly bed and stable banks upstream from step in channel (E); E: step in fine-grained bed (cf. Figure 4); F: bank erosion at swimming hole, confluence with former channel at left of image (cf. Figure 5); G: character of channel downstream (sandy-gravel bed, with mainly vegetated banks).

There is, however an 'anomalous' reach in the vicinity and upstream of the swimming hole (Figure 2). Here the bed has been stripped of gravel and sand and the channel runs over cohesive fine-grained sediment. Approximately 20 metres upstream of the swimming hole a step appears to have developed in the river bed. This cohesive material is resistant to hydraulic entrainment (erosion by clear-running

The tributary in the downstream section was noticeably wider (Figure 2) than reaches upstream and local observations report a widening has taken place here in recent years. Recent widening suggests the channel dimensions are not simply a response to accommodate more discharge supplied by a tributary joining the channel immediately downstream of the swimming hole (cf. Figure 2). Waveney Warth notes the following important information: “We understand that circa 2017-18 existing planting of the stream edge downstream of the swimming hole and bridge was destroyed by bulldozer / digger. There were large macrocarpas, willows and poplars. 2) Upstream of the swimming hole on our property we removed about 4 or 5 mature willows in summer of 2022-23 - this was the same time that the neighbours had their willow work done.” (personal communication, 26 March 2024). However, the condition of the banks in this reach is not obviously anomalous: vegetation is abundant, it appears fresh bank cutting is not particularly prevalent, which in turn suggests the initial phase of adjustment may have been completed. However, without dense-rooting vegetation (e.g. willows or, as an alternative native, cabbage trees) the channel may be vulnerable to further widening and adjustment in the event of a very large flood (high magnitude or long duration).

Planting of dense-rooted vegetation along the top of banks in the lower section of the Awa Matakana (Figure 2) may improve the resistance of this channel to future significant flood events. However, care is required to ensure that the bank face is also protected to ensure that floods do not undercut and wash out bank top vegetation. A staged riparian strip could be deployed in the lower section, planting sedge grasses along bank faces and cabbage trees along the bank top. Detailed planting design and advice should be sought, including the type of plants and planting density. Bank re-contouring to reduce bank angle may be required to allow vegetation to become established and limit losses to washouts. Channel design advice should be sought if this option is to be considered.

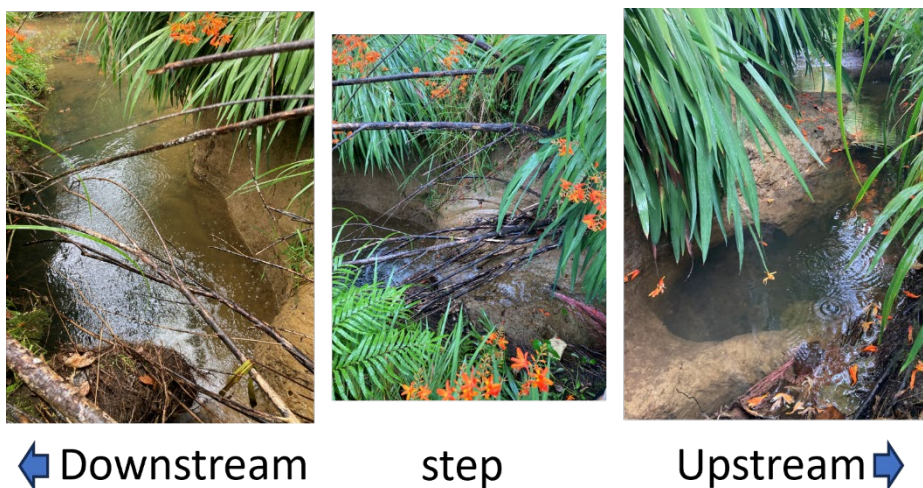
Figure 3. Condition of bed and banks of Awa Matakana channel in the vicinity of a bed step observed ~20 m upstream from the swimming hole (cf. Figure 2). Note the presence of a fine-grained bed at this location, as well as steep banks formed in the same cohesive fine material.

At the bed step (Figure 3), bed erosion of cohesive sediment is driven by overpassing bedload moved during higher flows (floods) in the tributary. Although not readily eroded by clear-flowing water, this material offers little resistance to being scoured by harder material, and even wood in the channel has left pockmarks on the surface (visible in Figure 3). Bedload (gravel) that gets trapped in depressions formed in this material can rapidly deepen the bed. Coalescence of potholes can result in significant and sudden bed deepening. Rapid upstream retreat of this step, deepening the channel here has been observed by FOAM in response to recent high flow events during 2023. Incision of the bed does not appear to have resulted in bank instability at this location, since the high cohesion of material allows for near vertical banks to be maintained. However, it is possible that a step in the bank top (land dropping towards the channel) along this reach may be a consequence of bank undercutting and this may result in a deeper-seated failure (slumping) of the bank. It is also possible that the weight of mature plane trees along this section of bank is contributing to this deeper-seated failure.

Bed step retreat ~20 m upstream of the swimming hole is likely to continue. This process risks deepening the channel bed upstream and eroding any underlying cohesive sediment, which will contribute to elevated suspended sediment loads in the Awa Matakana, since the sediment is fine grained and transported in suspension (or as washload). This process may also trigger deeper-seated bank instability.

Treatment of the bed step reach should be considered to prevent what appears to be an anomalous process from extending upstream and potentially degrading what appears to be a stable channel form (in both bed and banks). Further bed step recession will also degrade water quality by elevating suspended sediment loads and contribute to large-scale (deep-seated) bank failure. Large wood in the channel and banks of the Awa Matakana appears to be particularly effective at contributing to bed and bank stability (Figure 4). Large wood also serves to dissipate flood energy by adding to channel roughness and resistance to flow. The consequence of retarding flow by wood emplacement is however the likelihood of increasing overbank flows, since flood waters will not be as readily evacuated. However, in turn 'slowing the flow' is a recognised 'nature-based solution' to flood mitigation being deployed around the world (and notably by the UK Environment Agency, albeit in a different environmental context) and by encouraging connection between the awa and its floodplain

Monitoring of the ground alongside this 'bed step' section of channel is recommended. If movement, which may be detected by leaning of the trees towards the channel, is observed, the removal of these trees may be required to reduce the weight exerted on the bank. Less heavy vegetation with a dense root network (e.g. cabbage trees) could serve as a replacement vegetation cover for these banks.

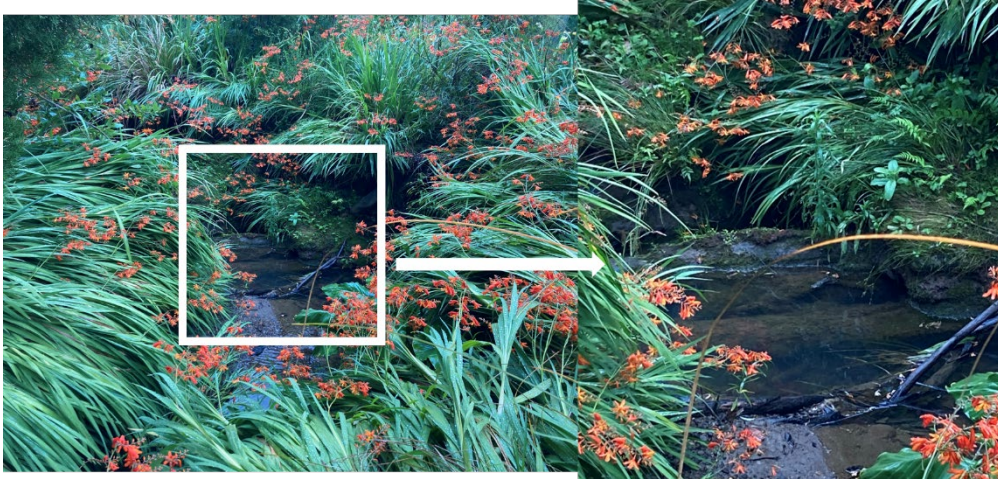
Figure 4. Right-angle bend on the Awa Matakana with large wood evident in the channel and bank, along with copious bankside vegetation.

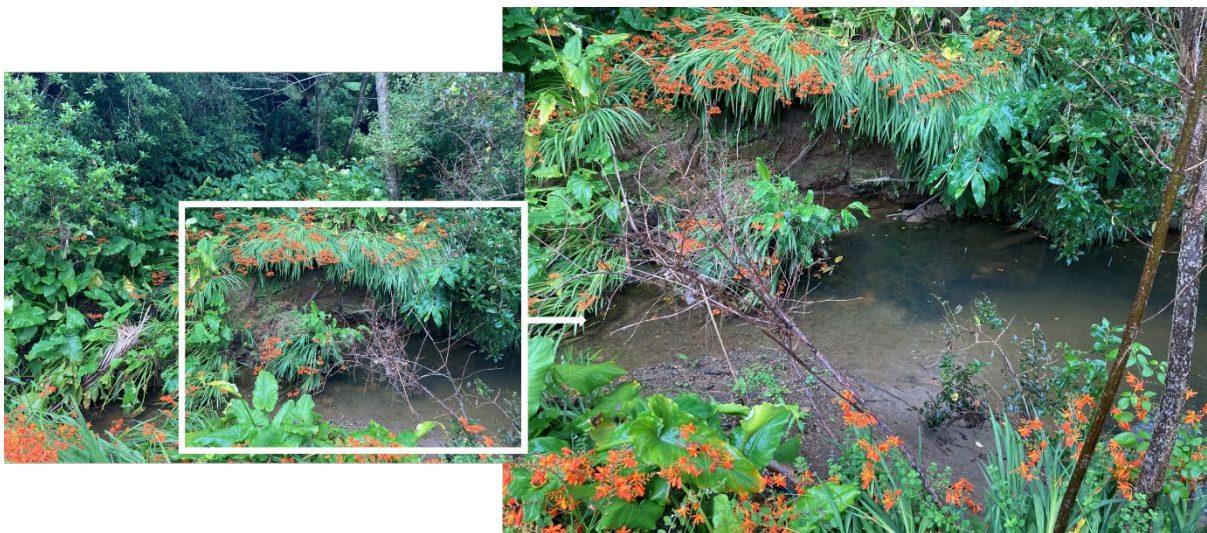
Figure 5. Bank erosion and bed scour at swimming hole

The difference in bank material at the swimming hole location most likely reflects the juxtaposition of the old channel at this site. Here the river in its former course has deposited alluvium over time and the new course of the river has now cut into this material. Alluvium is sediment that is transported by the river and deposited within and adjacent to the river channel by natural fluvial processes. Since the stream is competent to transport gravel and sand (cf. Figure 2) in this part of the catchment, alluvial deposits are likely to be coarser than the cohesive parent soils. Accordingly, banks cut into alluvial material are less cohesive and more vulnerable to erosion than cohesive soil banks.

At the swimming hole bend, erosion of the outside bank is consistent with expected fluvial processes, with higher stream power focused towards the outer bank, and directed into less cohesive sandier banks. This is not an anomalous process and is part and parcel of a river being a river.

Some further bend extension and scour will likely occur at the swimming hole. This is a natural process.

No mitigation measures are recommended for the swimming hole bend, because this is a natural fluvial process of bend adjustment in naturally occurring and exposed alluvium. Rivers adjust over time, they are not static features and natural processes of adjustment should be accommodated wherever possible.
