LE ROY'S BUSH SCENIC RESERVE SLIP REMEDIATION PLAN

LE ROYS BUSH SLIP REMEDIATION PROJECT (DRAFT 1)

ENVIRONMENTAL IMPACT ASSESSMENTS CLIENT REPORT A2E JUNE 15 2024

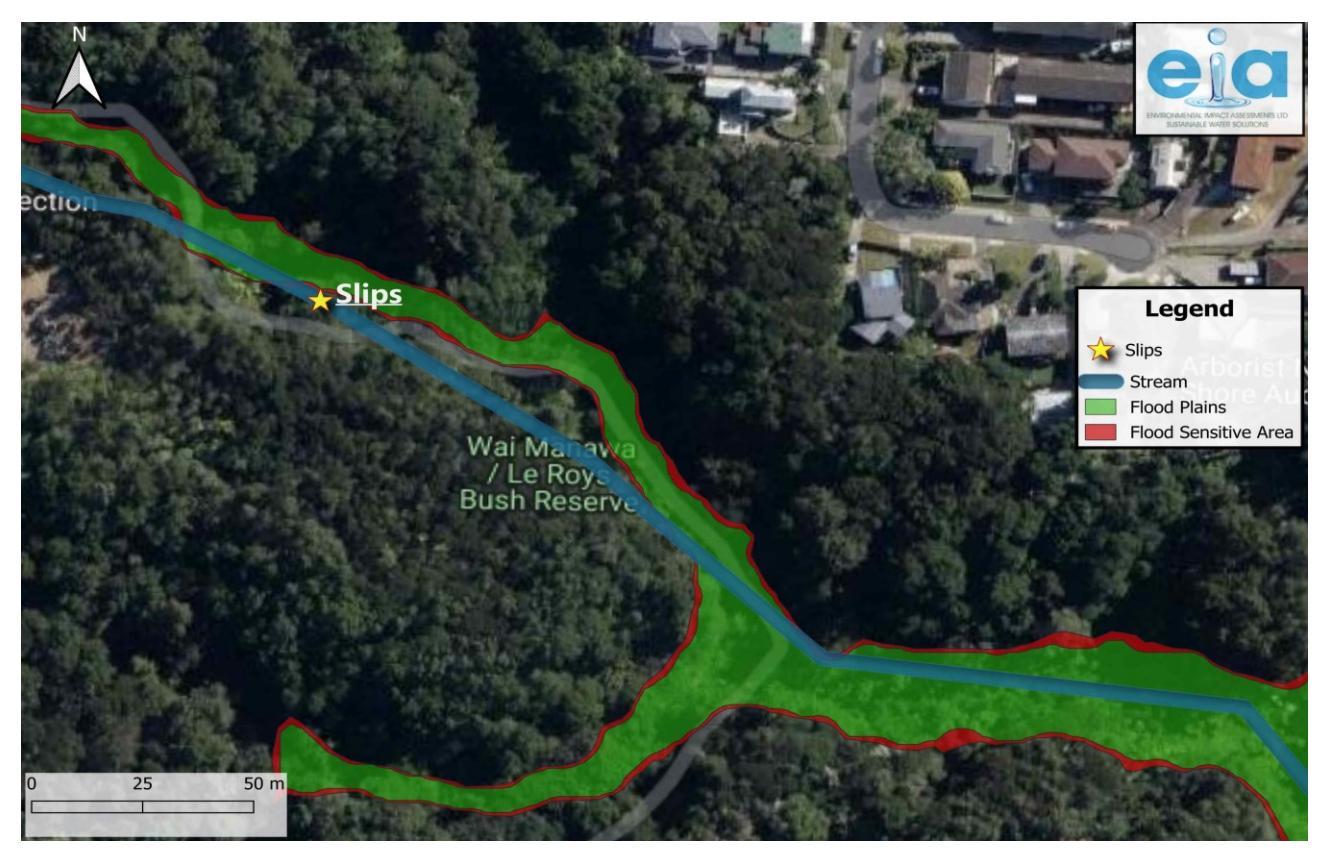
FIGURE 1: LOCATION OF SLIPS

Figure 1 shows the approximate location of the two major slips within the reserve. Stream and overflow GIS data were obtained from Auckland Council GeoMaps.

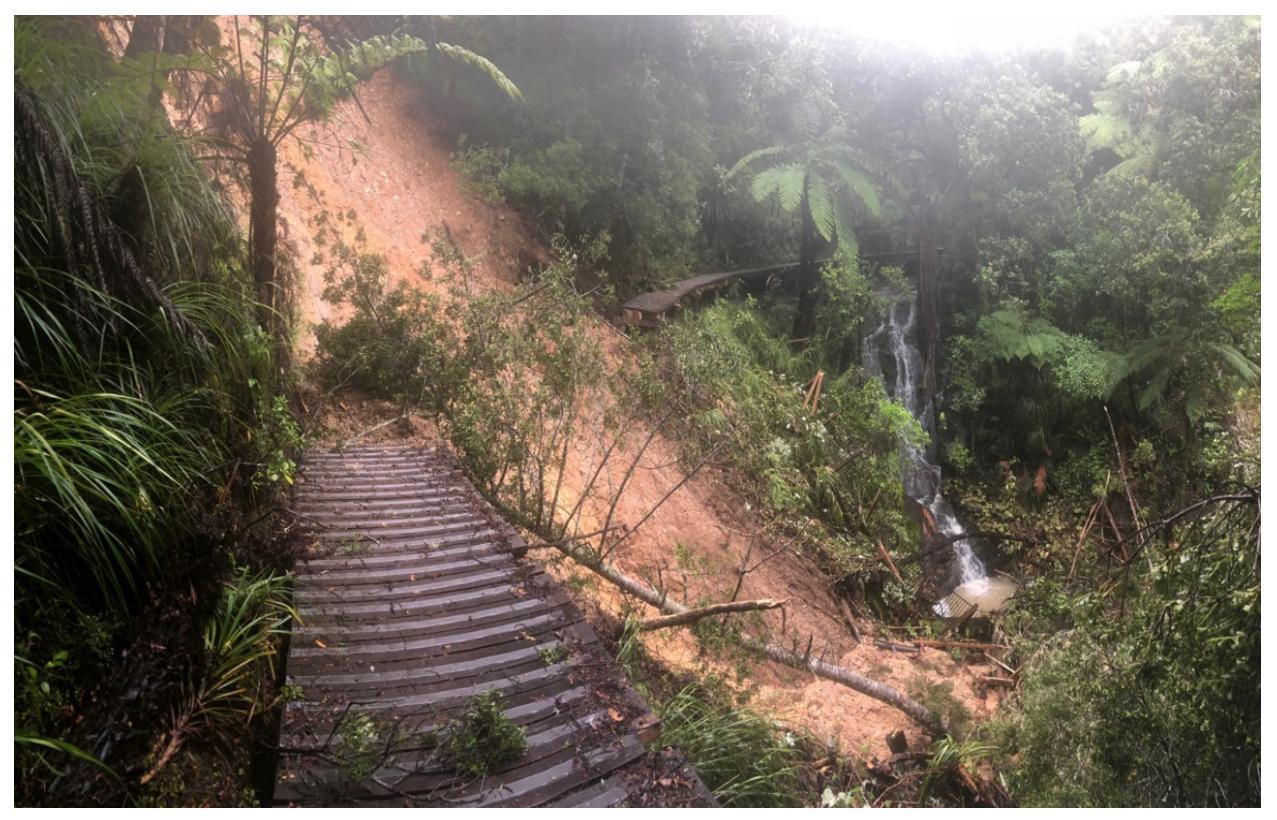
FIGURE 3: WATERFALL – A NOTABLE FEATURE

The slips occurred on the 27th of January 2023, during cyclone Gabrielle. Figure 3 shows post- slip photos taken by the community group FOLRB. A notable feature near the slips is the waterfall (seen in Figure 3), which is located approximately 17 metres NNW of the largest slip (slip 2) on the true right bank of the stream. It is likely that the weight of the water logged soil profile on the steep slopes resulted in the land slips at the two sites.

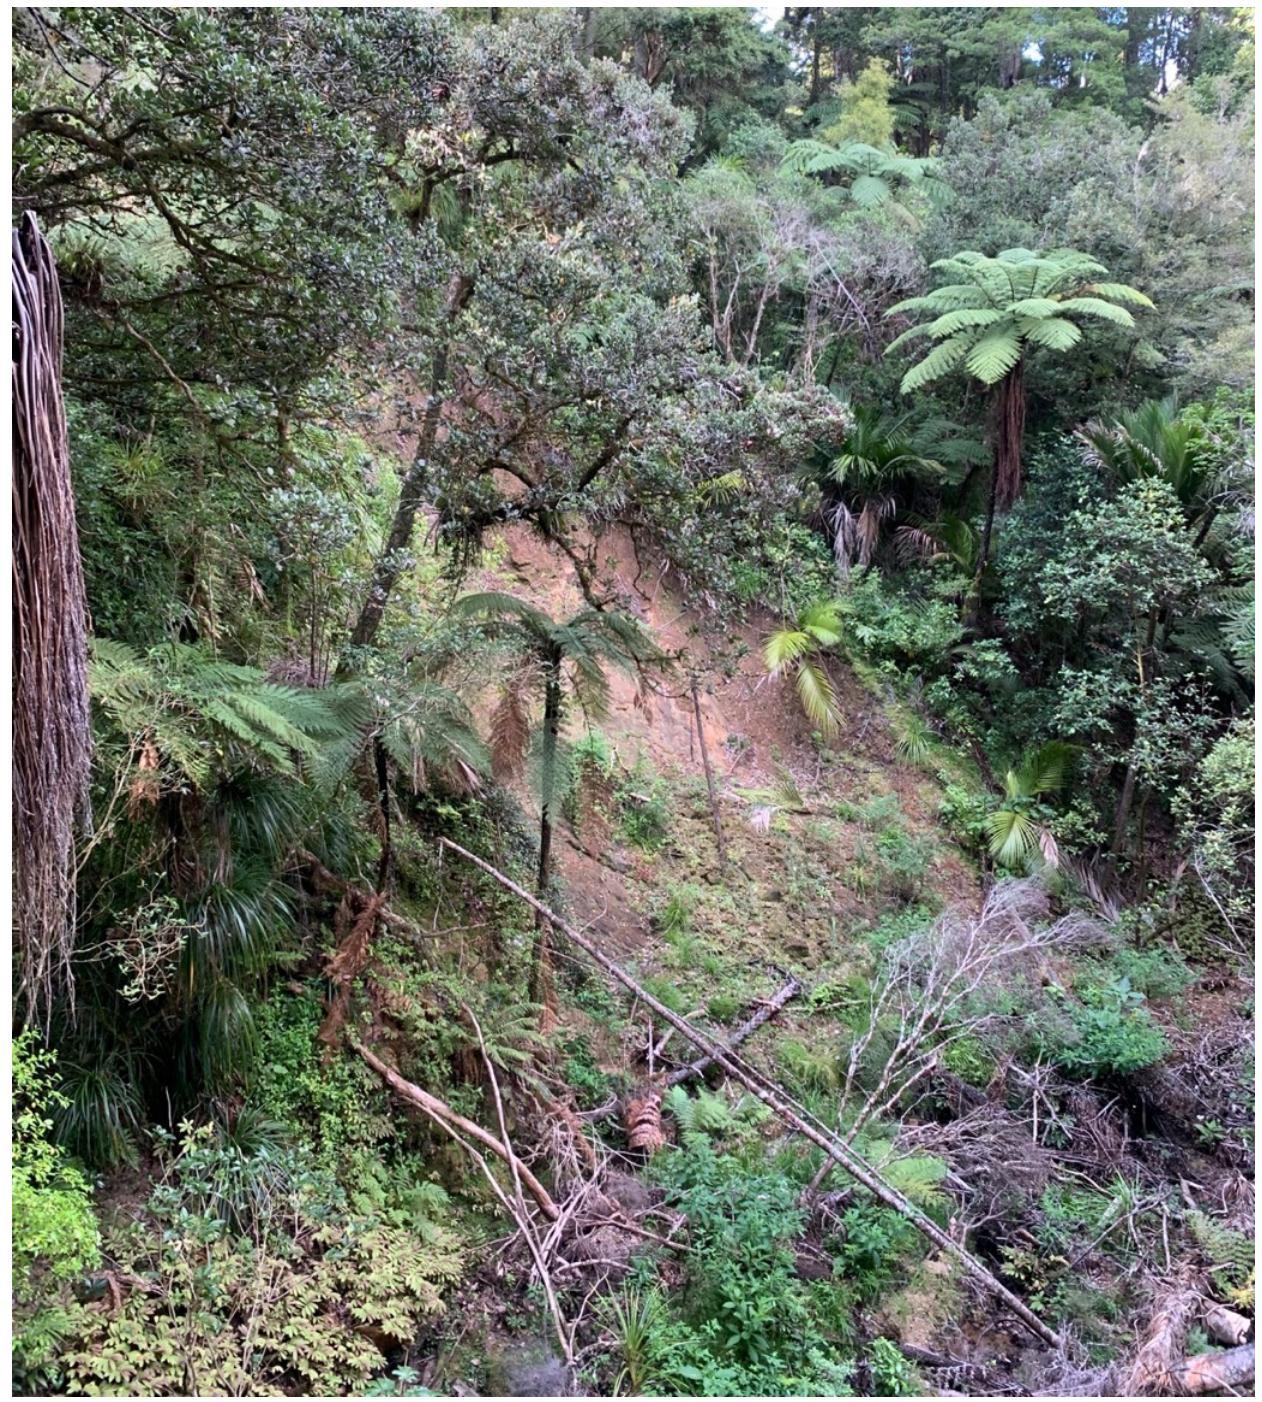
FIGURE 4: LOWER SLIP 1

Figure 4 shows the true left bank view of Slip 1 of which grass regeneration is occurring in the lower section. Prominent plants seen are Mānuka (*Leptospermum scoparium*), Nikau palms (*Rhopalostylis sapida*), New Zealand begonia (*Elatostema ru*gosum), and king ferns (*Ptisana salicina*).

Slip 1's horizontal distance from top to bottom was estimated from these coordinates to be approximately 20 metres at maximum, whereas slip 2 is estimated at 25 metres. Both slips are approximately 10 metres wide and approximately 17 metres in height (vertically); however, slip 2 has a much steeper angle (approximately a 45-degree angle from horizontal) and is therefore likely to be much more dangerous and difficult to restore. No large rocks or boulders are exposed as the soil horizon remaining at each slip is mostly clay-dominated subsoil (B horizon), with little organic matter present.

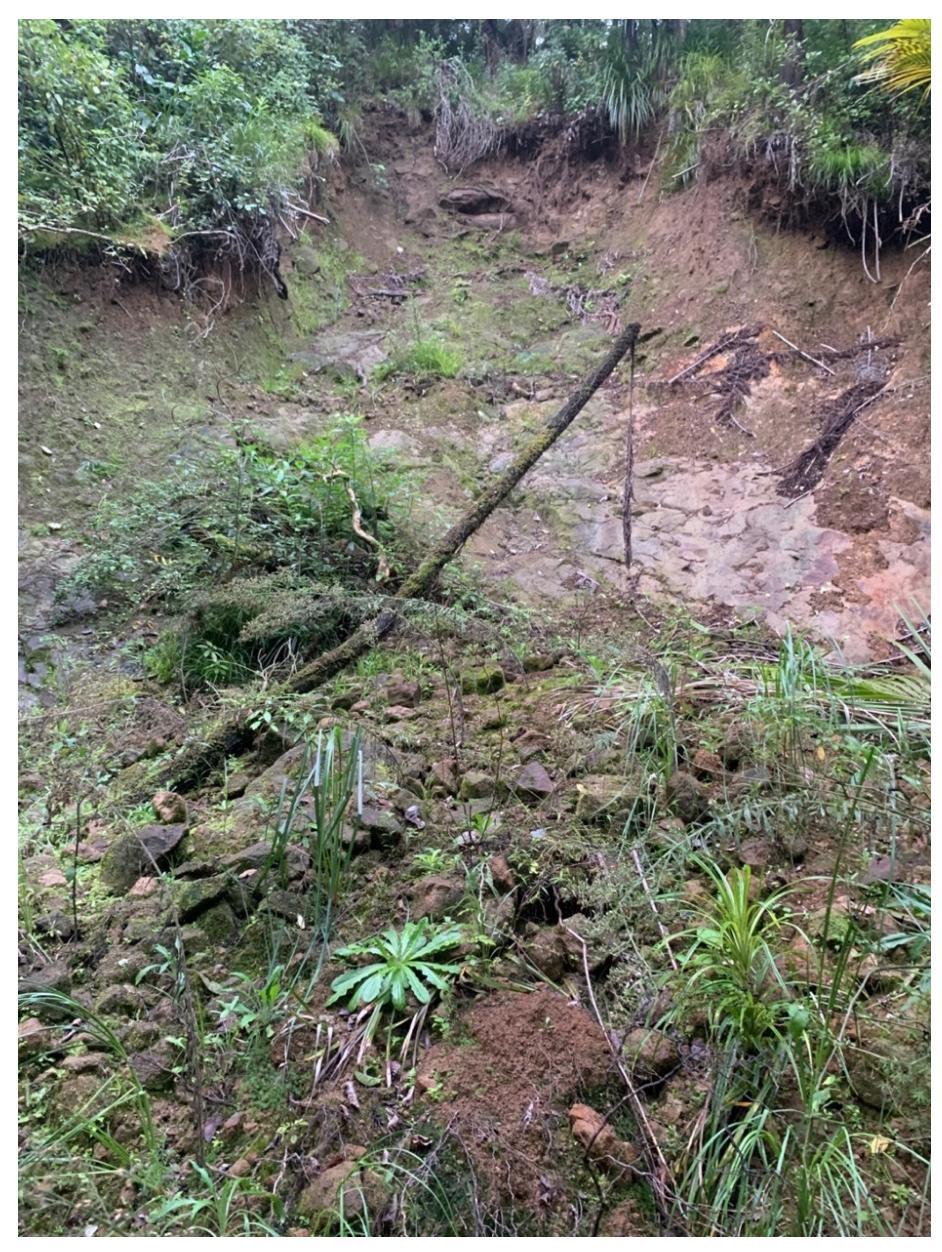
Slip 1 is the smaller of the two slips and has a large amount of debris at the base. Grasses are growing and regenerating within this depositional zone which has good topography and water holding capacity for vegetation to colonise this area. Figures 5 – 6 overleaf show photos of regenerating vegetation. In some areas weed species such as inkweed (*Phytolacca octandra*) and woolly nightshade (*Solanum mauritianum*) have been outcompeting native species for space to regenerate. However, a few native species which are recolonising on the lower section of slip 1 are Mānuka (*Leptospermum scoparium*) and Coprosma (*Coprosma repens*), which are key primary and pioneer species. This highlights that the natural processes of succession and regeneration are still occurring for some native species (Department of Conservation, n.d.). Prior to the slip occurring (in 2018), a high percentage of king fern (*Ptisana salicina*) and kiekie (*Freycinetia banksii*) were present (Figure 7) and later recorded after the slip, buried within the debris (Figure 7).

FIGURE 5: SLIP 1 TAKEN IN MAY 2024 Figure 5 shows the true-left bank slip (slip 1) mid to top section, taken in May 2024.

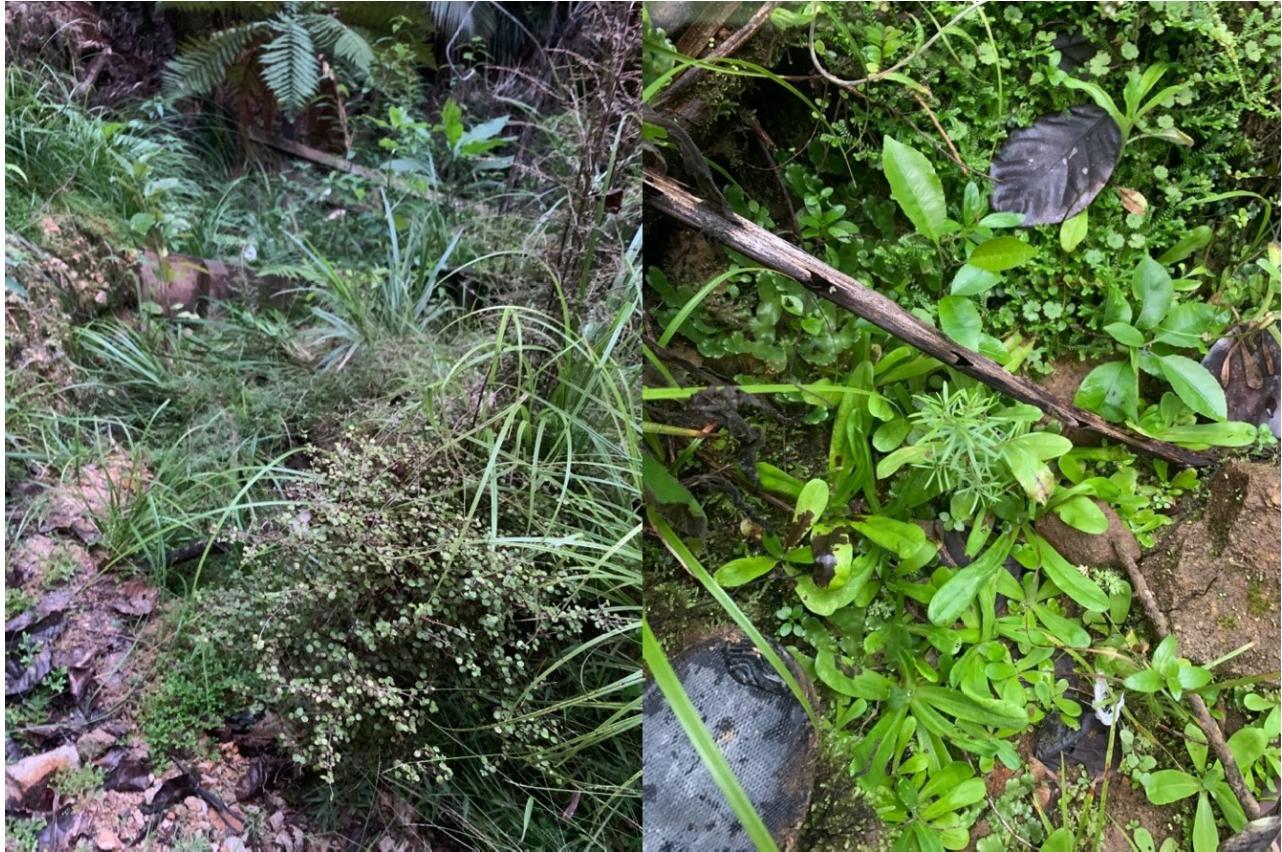
FIGURE 6 PIONEER AND PRIMARY SUCCESSION PLANTS REGENERATING

Figure 6 shows the primary succession plants regenerating naturally at slip 1. The photo was taken in May 2024 approximately 1 year after the cyclone event. Colonising species include pōhuehue (*Muehlenbecia axillaris*), karamu (*Coprosma robusta*), Kānuka (*Kunzea ericoides*) and Rautahi (*Carex geminata*).

Mānuka seedlings are recommended to be planted within designated areas as there is already evidence that natural dispersal of Mānuka seedlings is occurring on the base of slip 1 (Boffa Mikell Limited, 2017).

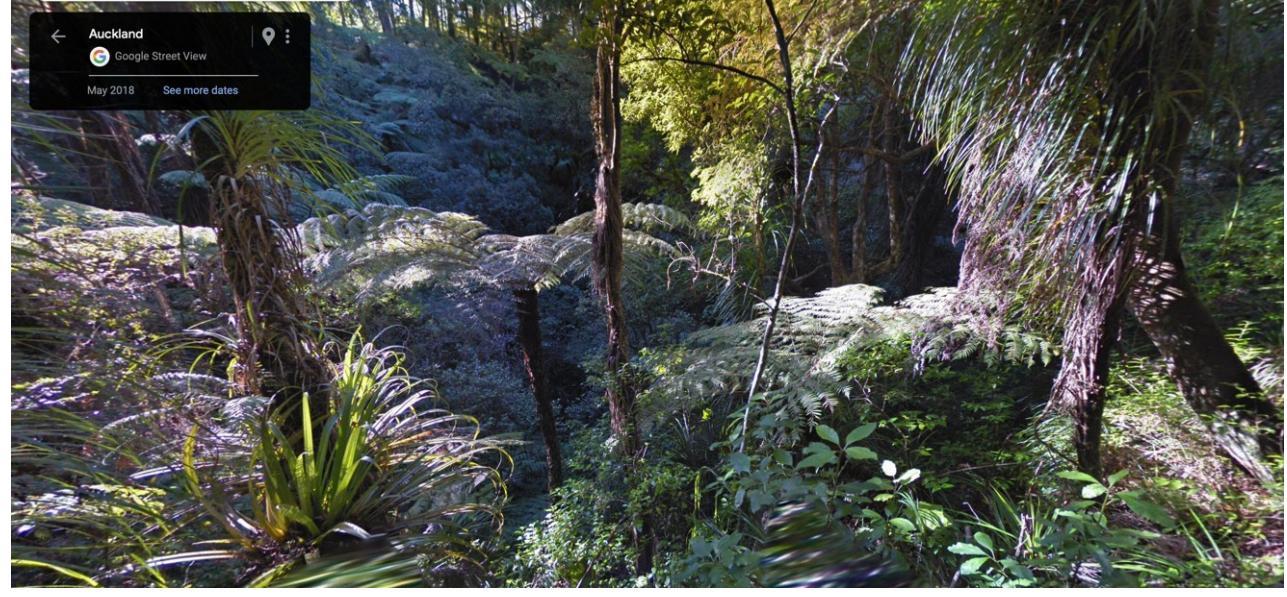
FIGURE 7: TRUE LEFT BANK VIEW OF SLIP 1 IN 2018

Figure 7 shows a true left-bank view of the slip location in 2018 (before the slips occurred), taken from Google Street View. This shows a large presence of king fern (*Ptisana salicina*) and kiekie (*Freycinetia banksii*) pre-slip. These photos provide a good reference to ensuring replanting selections and recommendations are appropriate for the reserve.

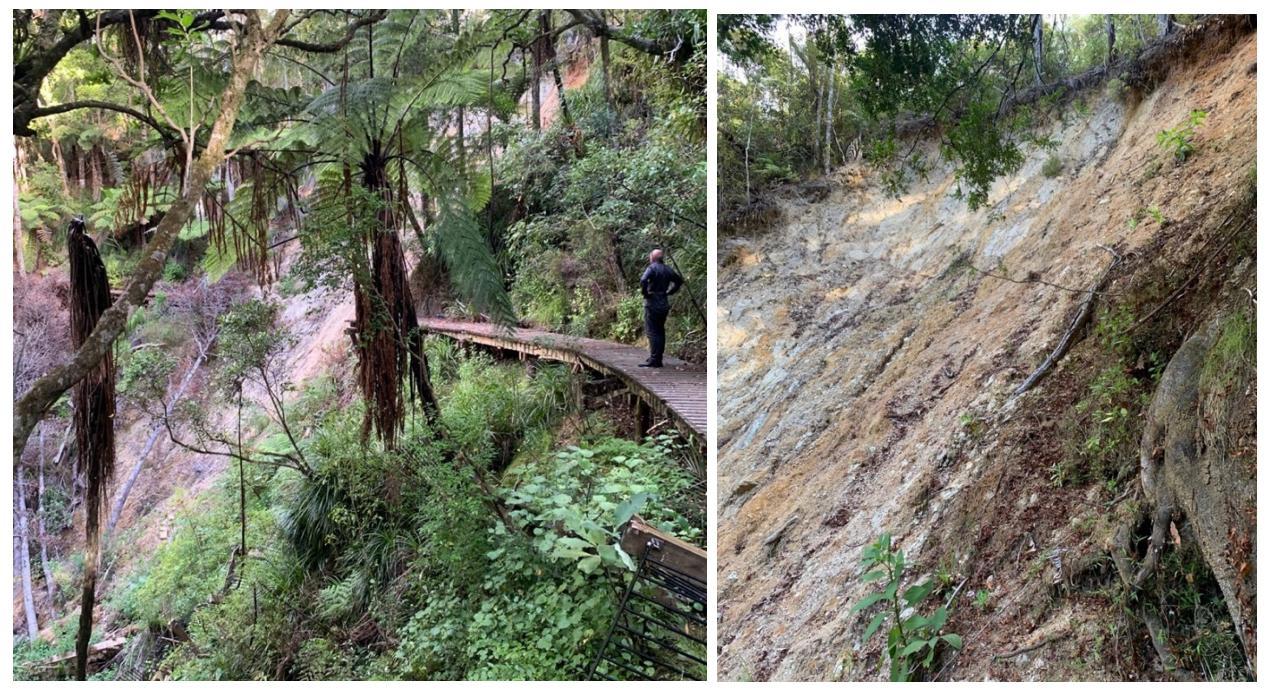
FIGURE 8: TRUE RIGHT BANK SLIP

Slip 2 is the steepest of the two (although not as wide) and is characterised as a scar slip. Scar slips generally have a hard clay base with very little topsoil structure and steep topography that provides for poor regeneration of plants depending on moisture, soil fertility and further weathering of the surface (Environmental Topics, n.d.)

There is less evidence of regrowth at slip 2 when compared to slip 1, likely due to its steepness and lack of topsoil. Slip 2 is mainly comprised of soil horizons B and a minor amount of C, and therefore mostly clay; new plantings must be able to withstand a more moist environment with less fertile soil and less organic matter. Although these slips will eventually be repaired on their own by natural succession (Johnson, 2019), this may take a very long time, and may not reach previous productivity levels.

Figure 8 shows the true right bank scar slip taken from the board walk on May 2024. This feature has remained devoid of vegetation since the slip appeared after cyclone Gabrielle.

A study on scar slips after landslides in the Wairarapa found that areas, where soil was left to naturally generate over time, had reduced grass growth after several decades with no improvements, compared to those that did not have scar slips (Rosser & Ross, 2011). This indicates that slip remediation measures will likely be required for slip 2 to maximise ecological restoration potential.

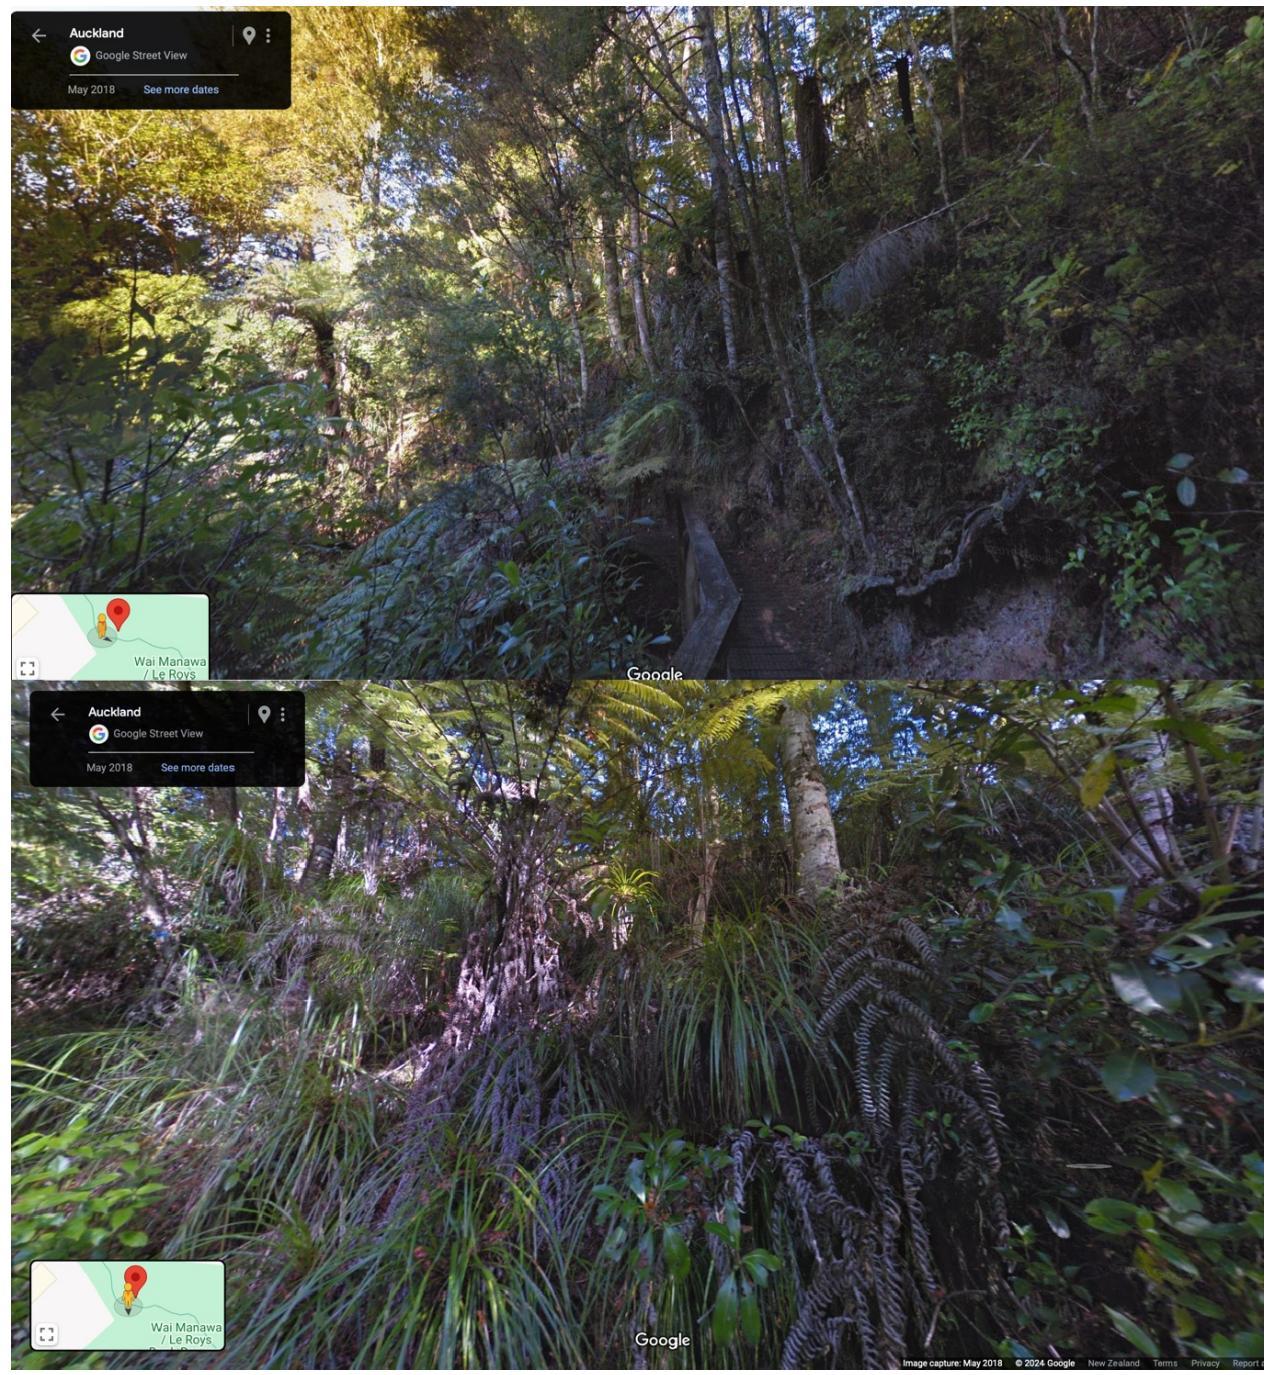
FIGURE 9: TRUE RIGHT BANK SLIP (SLIP 2) TOP (TOP) AND MID (BOTTOM) VIEW PRIOR TO THE CYCLONE

Figure 9 shows the top of the true right bank slip (slip 2) and mid areas prior to the cyclone (2018) taken from Google Street View. This shows that this area was previously vegetated with king ferns, coprosma, kiekie, and kahikatea.

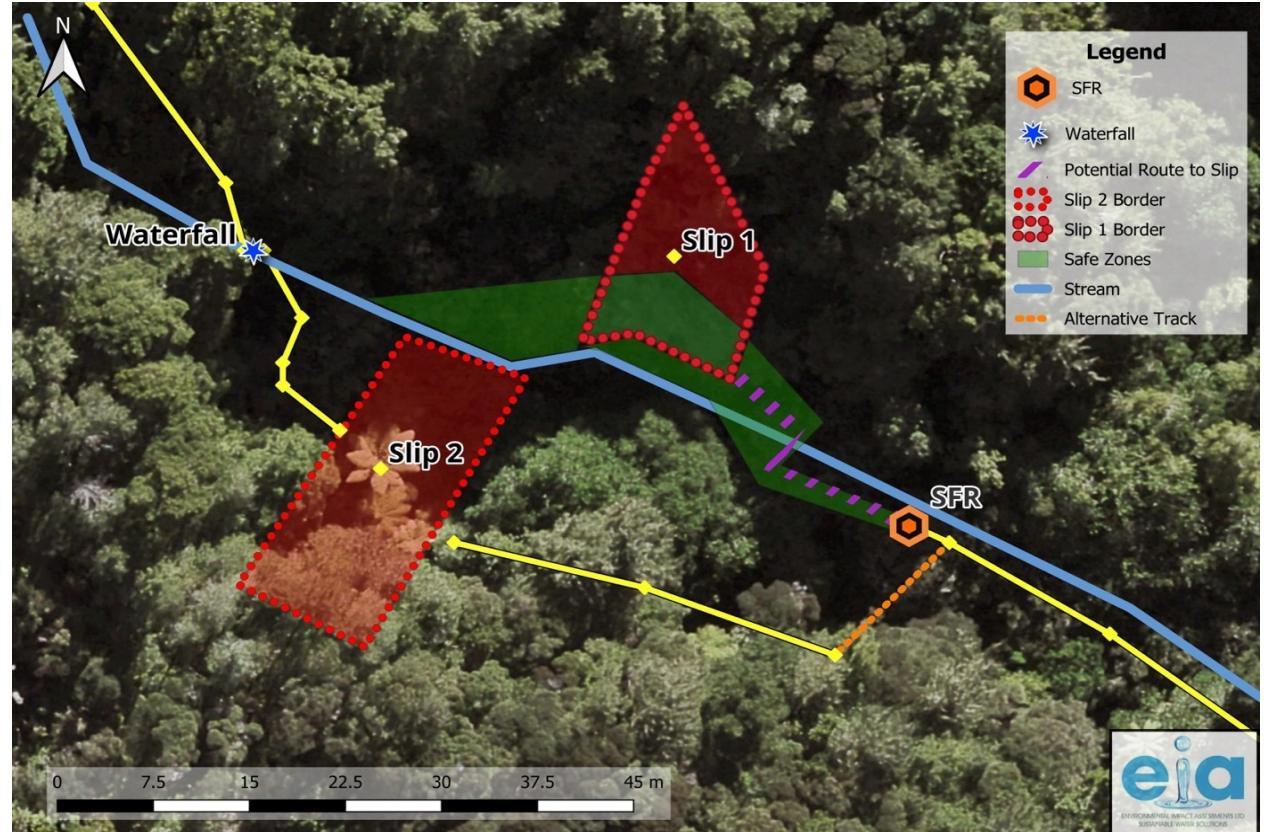
FIGURE 10: SLIP AREAS AND ZONES

Figure 10 shows the extent of the slip remediation project, with the orange marking labelled "SFR" for "Safety Feature Required" (SFR) indicating the location of a feature required to allow individuals working on the project to safely descend down from the path to access slip 1. The green polygon indicates a safe zone for which community plantings could be undertaken with minimal risk.

The safe zone (green polygon) should first be pegged out using waratahs and string to ensure community volunteers are working within a safe area. Polygons outside of the green safe zone are recommended for experienced contractors who have the expertise and equipment to work in potentially hazardous areas.

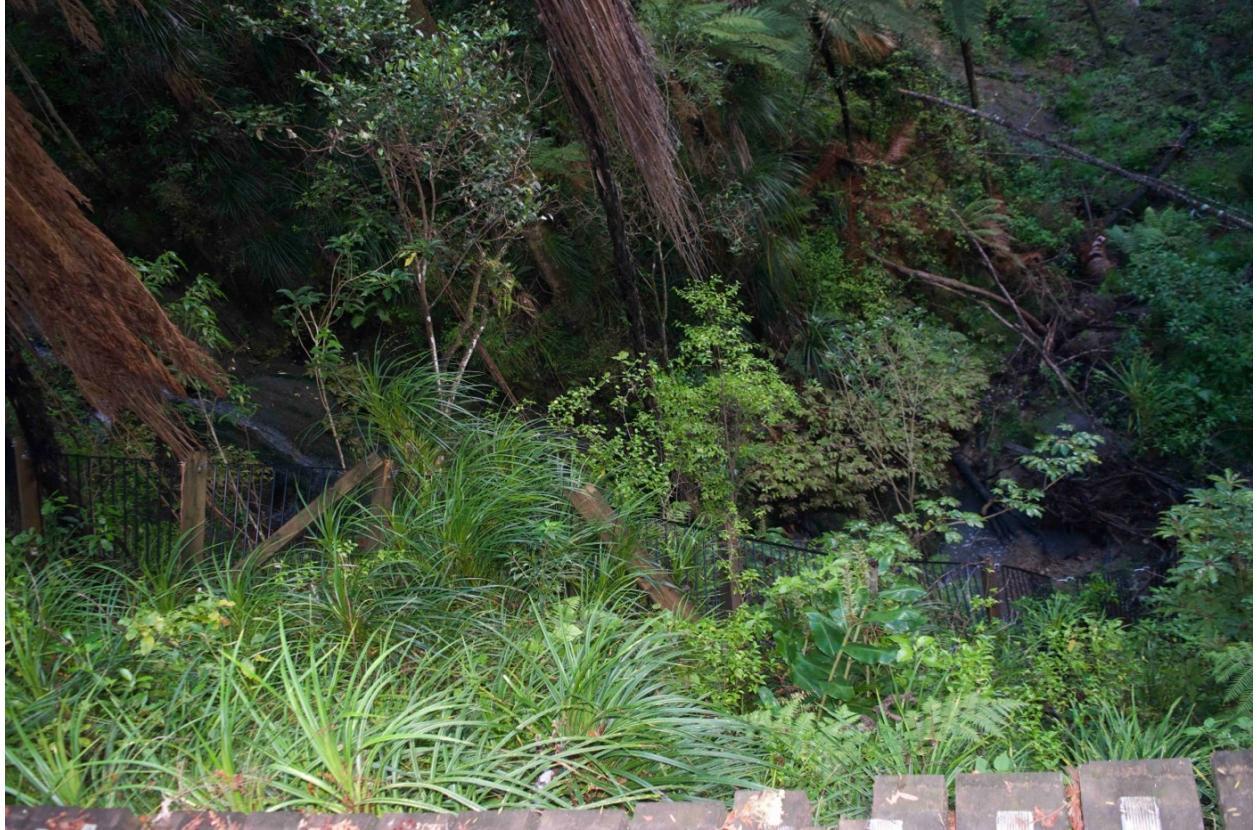
FIGURE 21: HANGING INFRASTRUCTURE IS HAZARDOUS

Figure 11 shows typical hanging walkway infrastructure that is unsafe for volunteers to be working near. This type of terrain and hazard risk is typical of areas outside the safe zone which is recommended to be worked on by experienced contractors.

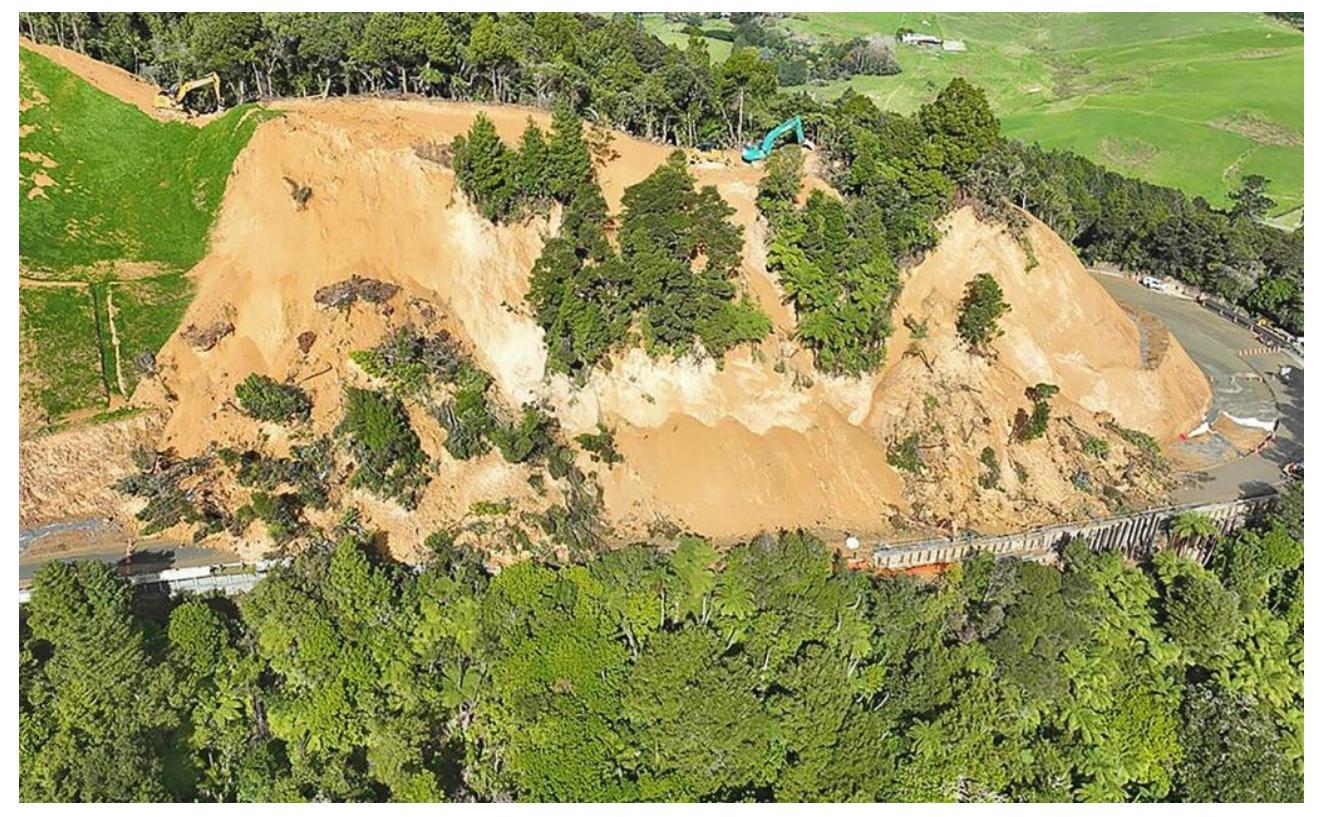
FIGURE 3: BRYNDERWYN HILLS HYDROSEEDING FAILURE

Hydroseeding is not always successful as evidenced by the Brynderwyn Hills State Highway 1 works. With high rainfall the success rate in exposed areas is not always guaranteed.

Hydroseeding is not recommended for slips 1 and 2 due to the inaccessibility of the site for a vehicle and trailer.

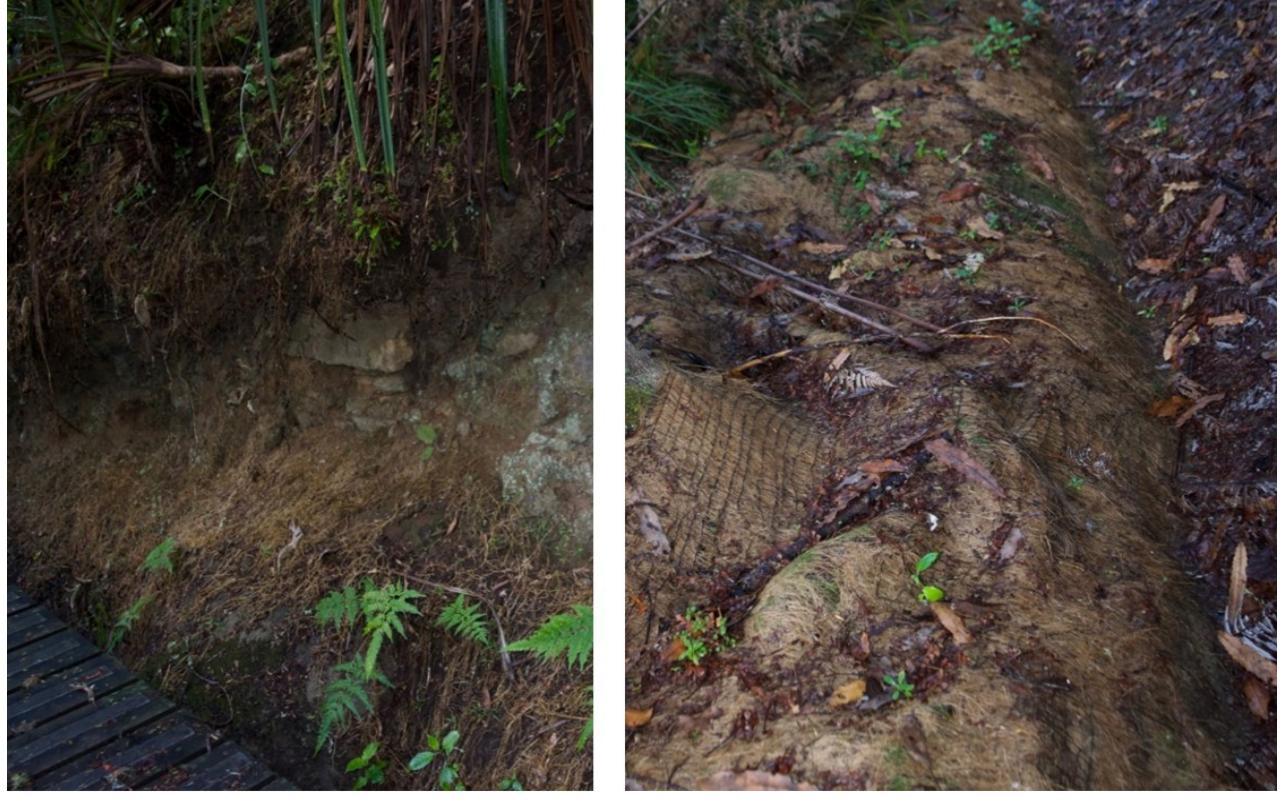
FIGURE 13: LEFT AREA COULD BE MATTED, RIGHT AREA PREVIOUSLY MATTED

Figure 13 shows an area that could be matted to prevent undercutting and movement. This is on the true right bank just after the waterfall. Figure 13 also shows an area that has previously been matted further north up the track.

In our view localised areas of matting could be undertaken in more gently sloping areas of the reserve, however for steep scars etc. it is strongly recommended to consult with a Geotech engineer first.
