Hauarahi Stream Report

Prepared for Ministry for the Environment
Prepared by Beca Limited

31 October 2023

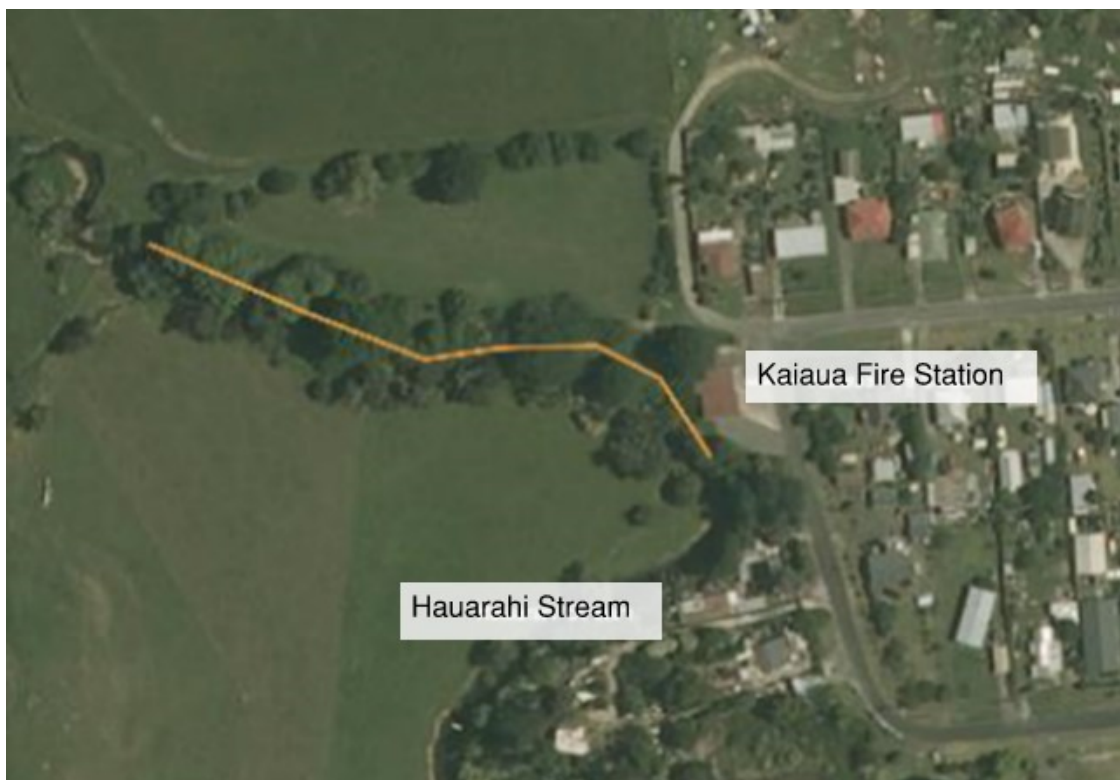
Figure 3. Potential inanga spawning reach in the Huarahi Stream identified by Jason Roxburgh, Living Matters Limited, 2018.

Planting of suitable inanga spawning habitat (i.e. tall, dense grasses, rushes and flax) within the lower reaches of the Haurahi stream identified within Roxburgh & McQueen (2015) would enable inanga spawning and overtime increase local populations.

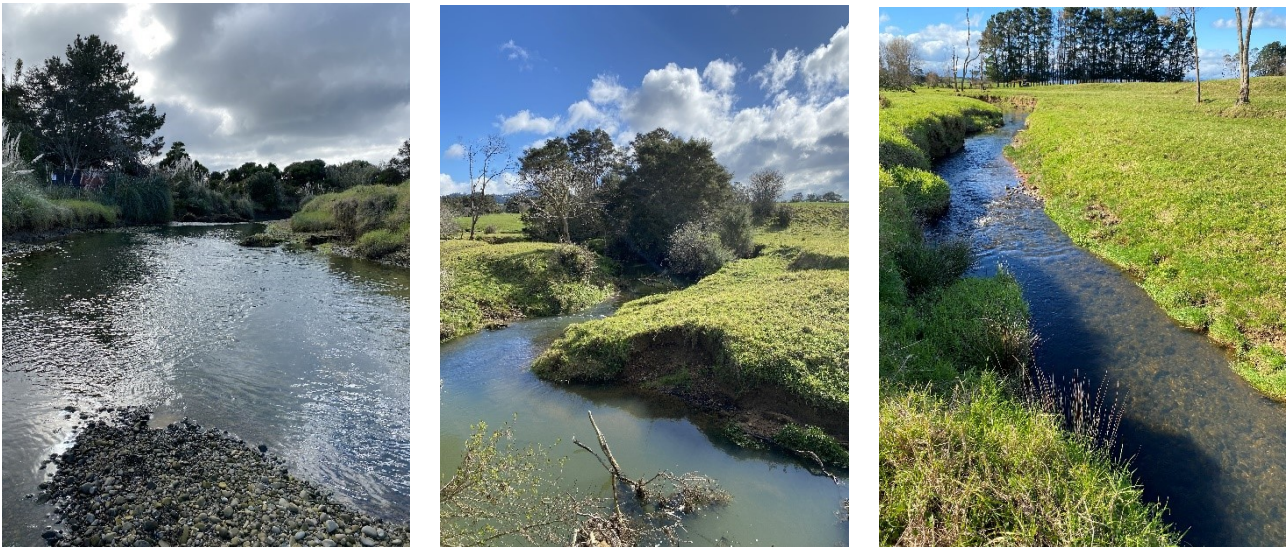
The lower reach extends from the estuary (County Bridge at East Coast Road) to approximately 350m upstream. The stream channel here is wide, hard-bottom and has good connectivity to the flood plain. Due to the proximity to the coast, this area is influenced by tides and saltwater intrusions. The riparian margin is poorly vegetated, however, an approximate 5m wide and 300 m long riparian buffer was planted by the Western Firth Catchment Group in 2020 along the true lefthand bank (TLB). Additionally, flood management in the form of a rock wall has been installed along approximately 75 m of the TLB reducing inundation of adjacent land and properties during high rainfall events. In general, the stream becomes straighter and narrower and riparian planting becomes sparse/ non-existent further upstream to Toft Road (Figure 4).

Figure 4. Stream channel and riparian characteristics from downstream (left) to upstream (right).

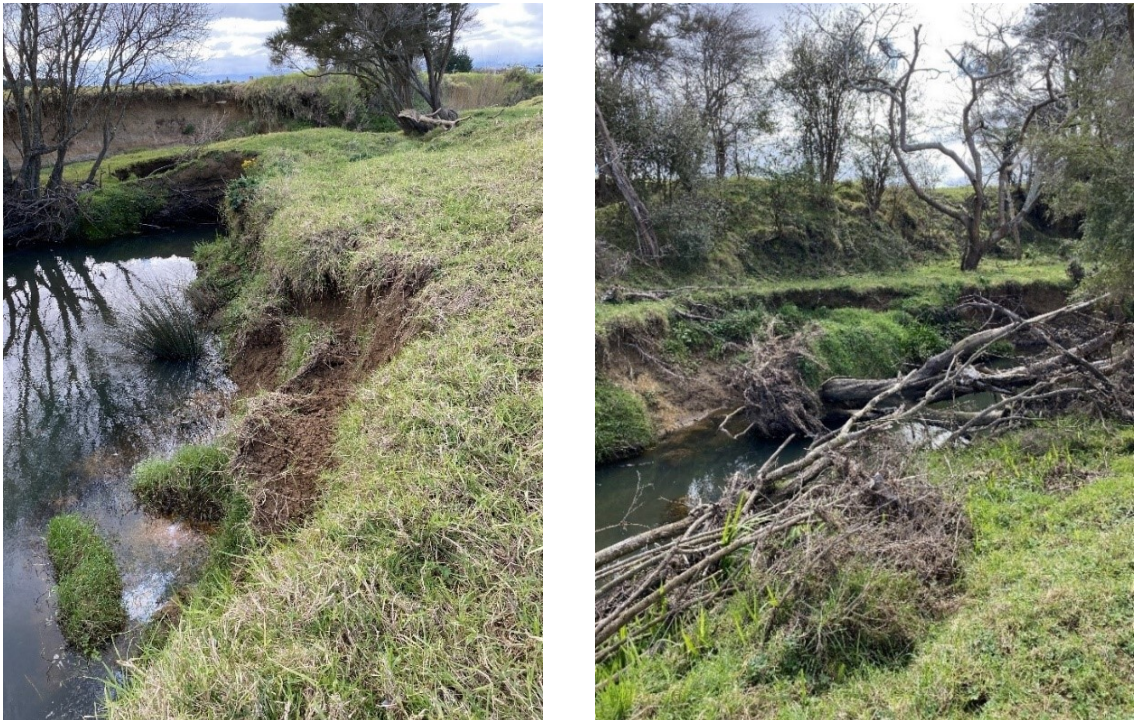
Extensive erosion scars (undercutting) as well as areas of active erosion (mass failure and slumping) was observed throughout the mid – upper reaches particularly where banks are high (Figure 5). Some areas of erosion appear to be due to fallen trees which were likely damaged during Cyclone Gabrielle (Figure 6). Fencing has been lost in multiple places due to mass failure. Additionally, three stock accessways through the stream were noted during the walkover, which are likely causing frequent pulses of sediment to enter the stream.

Figure 5. Examples of erosion along the Haurahi Stream.

It is recommended that any trees which are vulnerable to falling into the stream due to bank instability are removed to reduce sedimentation. Stumps should remain in-situ if an excess of sediment is likely to enter the stream.

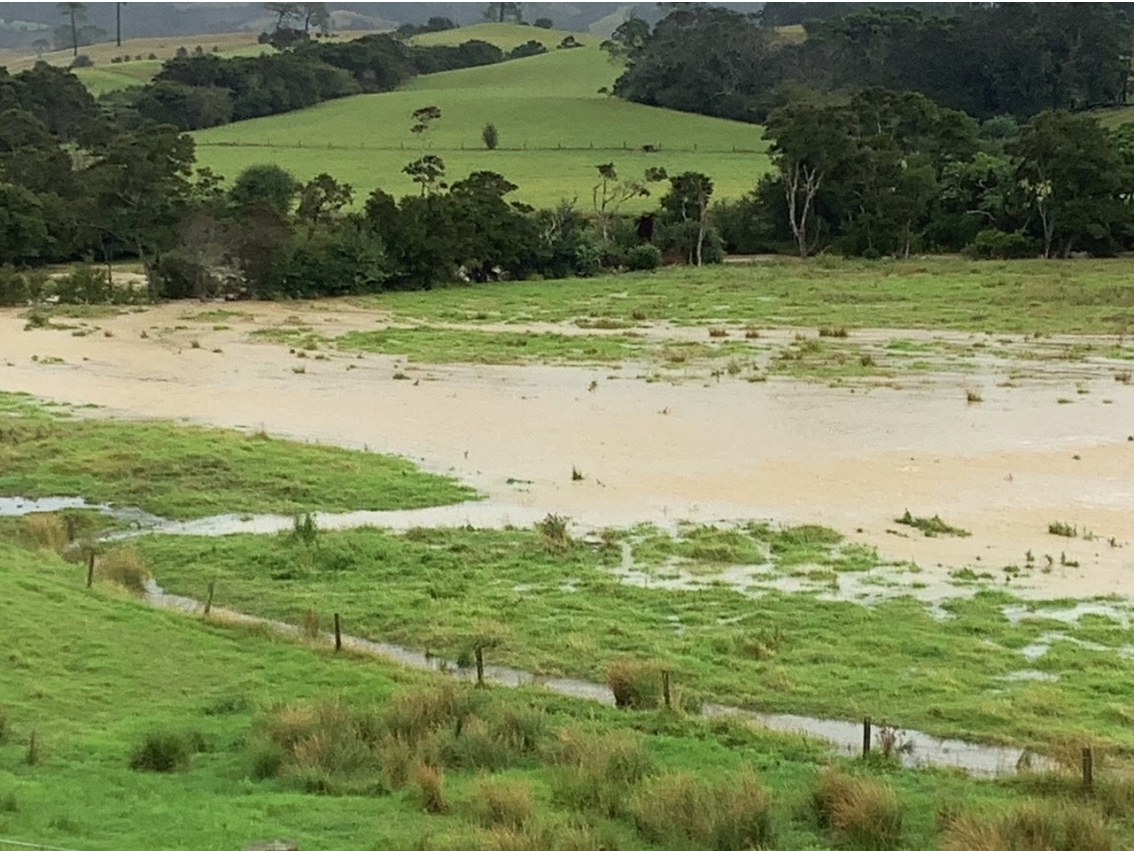
Figure 6. Flooding of the Johnstone farm during Cyclone Gabrielle on 23 January 2023 (Image provided by landowner Justin Johnstone).

Continued work with the Hauraki District council should be undertaken to manage the flood risk within the lower reaches of the Haurahi stream.

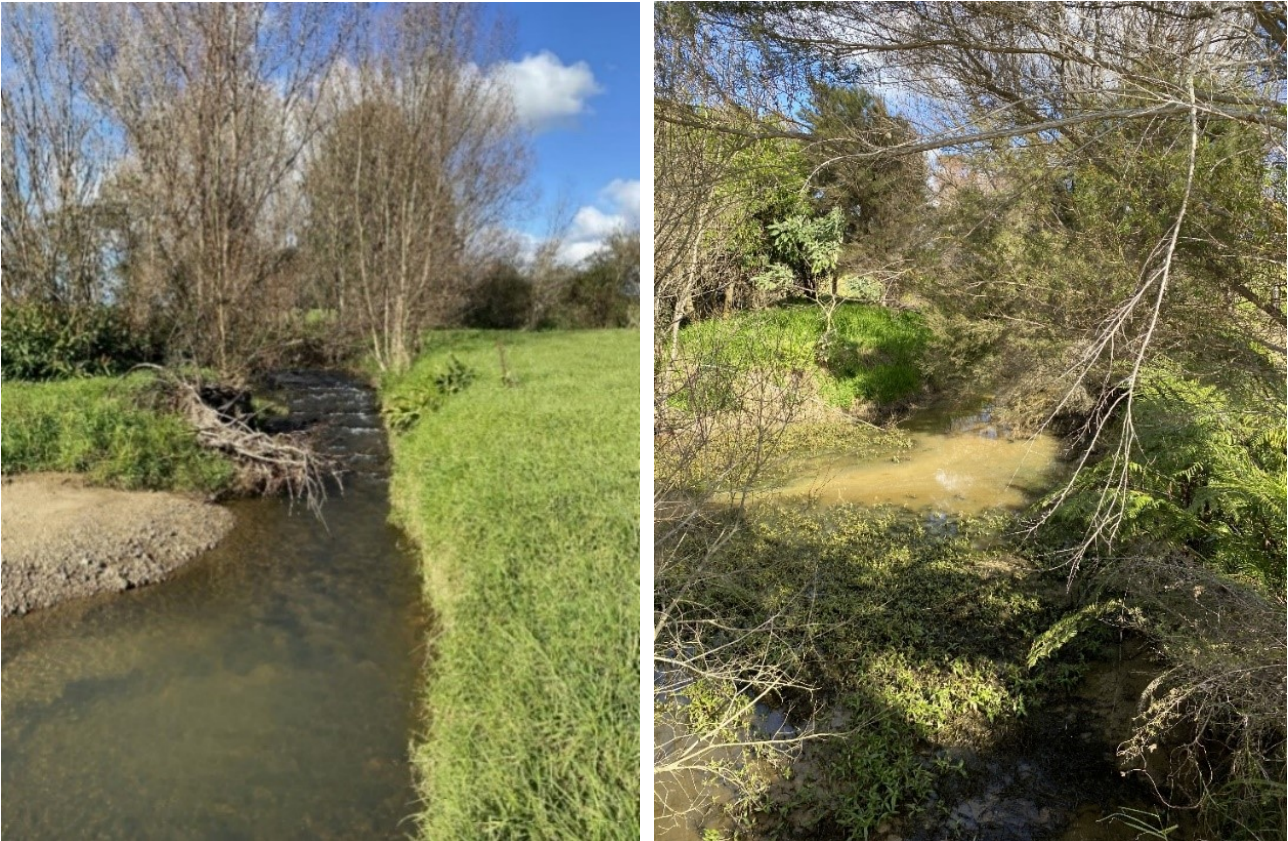
The water within majority of the stream was relatively turbid, areas in the mid-reach which had a high level of sediment. An erosion hotspot coupled with slow flows caused an area of extremely high sediment loading within the mid-reach section (see figure 6 below).

Figure 7. Example of water quality throughout the majority of the stream (left) and extreme sediment loading (right).

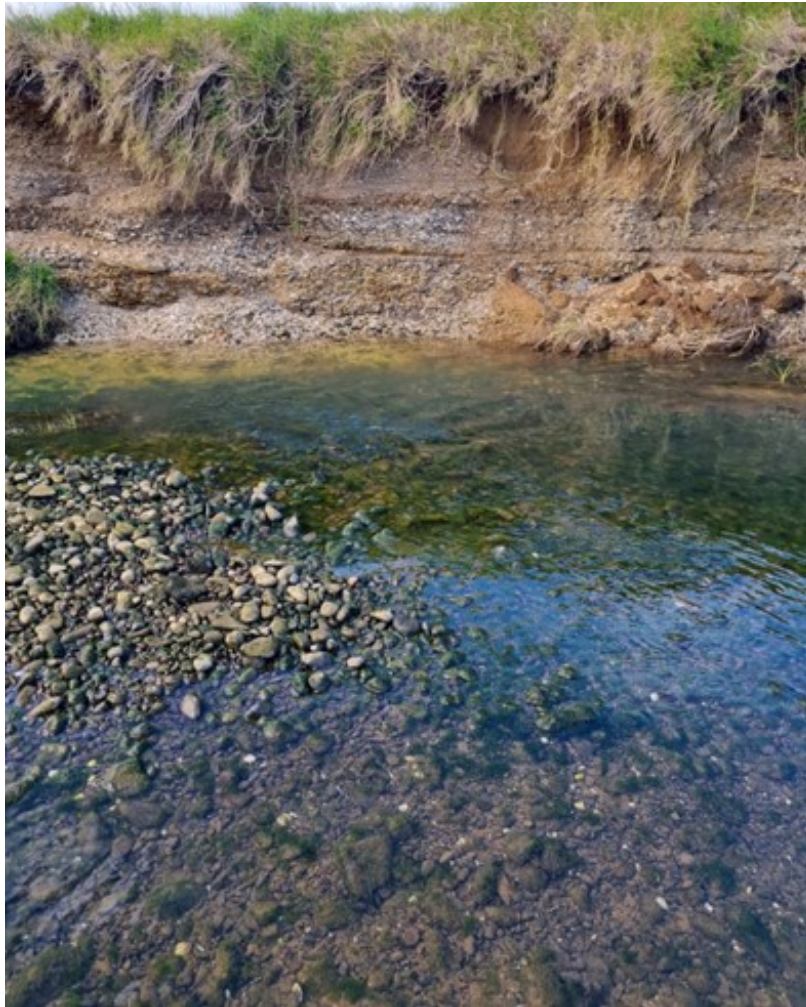
Due to the lack of riparian cover, nutrient loading from the surrounding farmland is expected to be high. Additionally, minimal shading throughout the entire stream is likely to cause high water temperatures during the summer months which leads to reductions in available dissolved oxygen for freshwater fauna. The excessive macrophyte and algal mat growth observed throughout the stream is likely to be a result of both high nutrient loading and minimal shading (Figure 8).

Figure 8. Excessive algal mat and macrophyte growth present within shallow, slow flowing section of the Huarahi Stream.

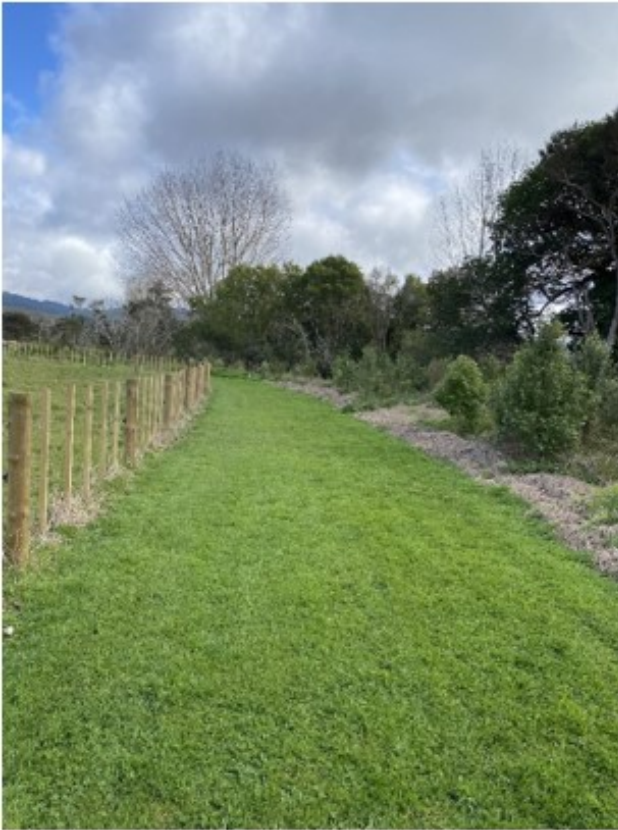
Figure 1. Fencing, grass strip and planting by WFCG.

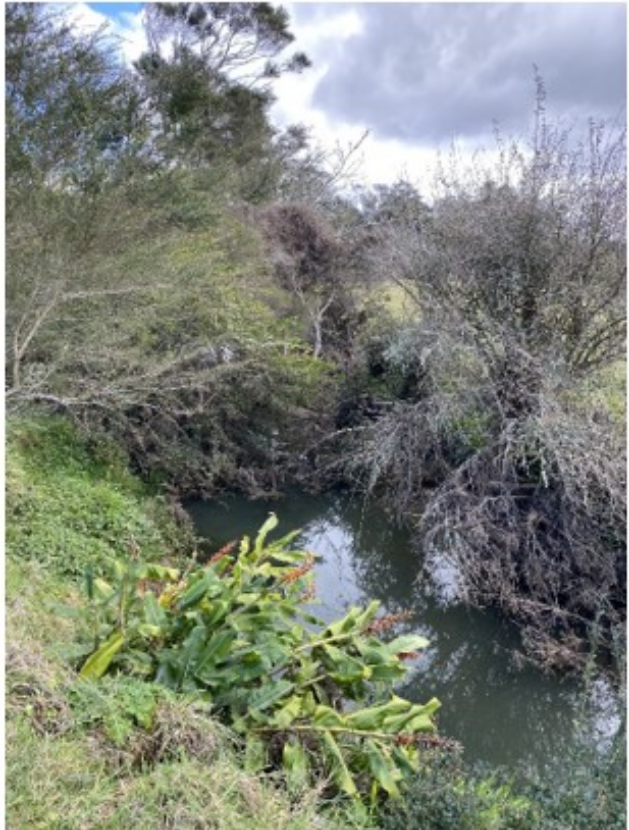
Figure 2. Pocket of native and exotic vegetation in riparian zone.

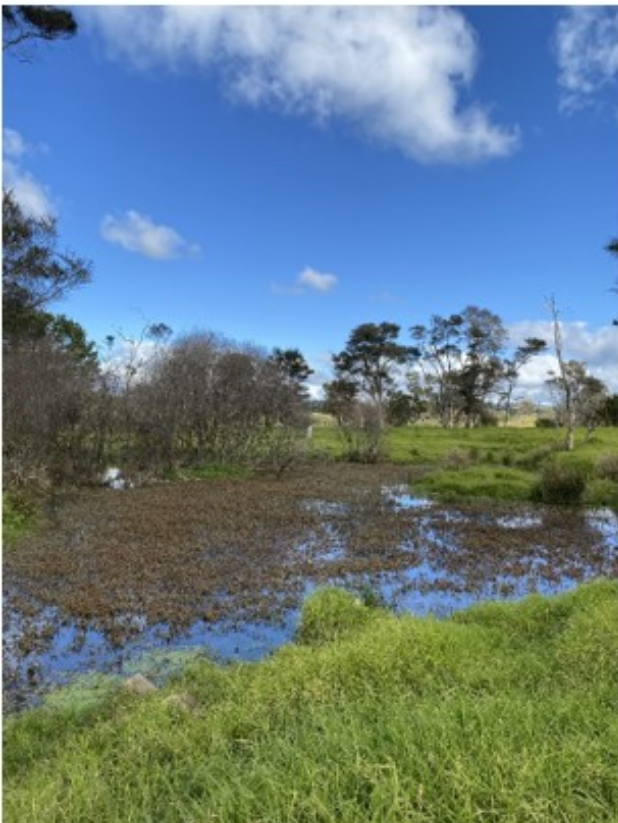
Figure 3. Seepage wetland area.

During the stream walkover, multiple degraded wetland and seepage areas were observed. It is recommended that specific wetland assessments are undertaken to inform future management of these areas. Management of these areas will also contribute to improving freshwater outcomes (and is consistent with the outcomes sought in the NPS-FM).

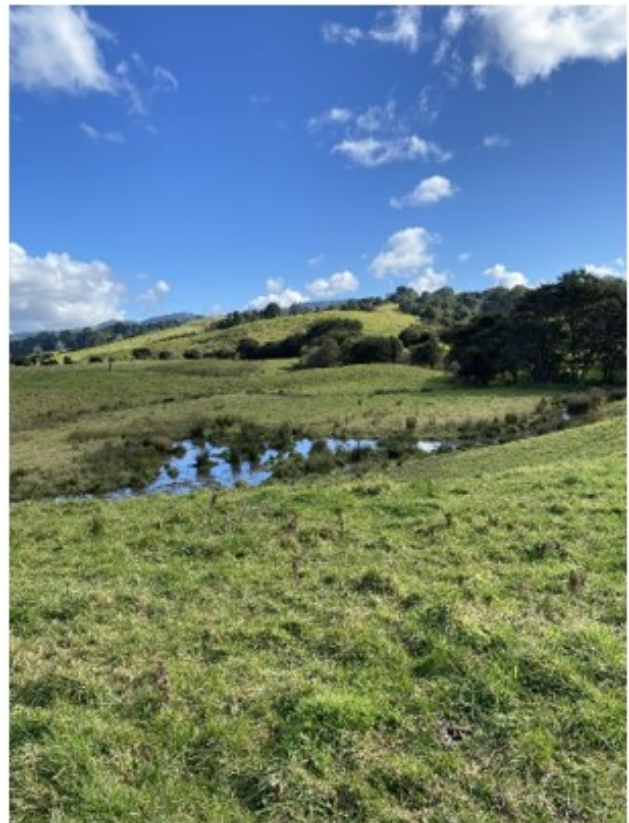
Figure 4. Wetland area.

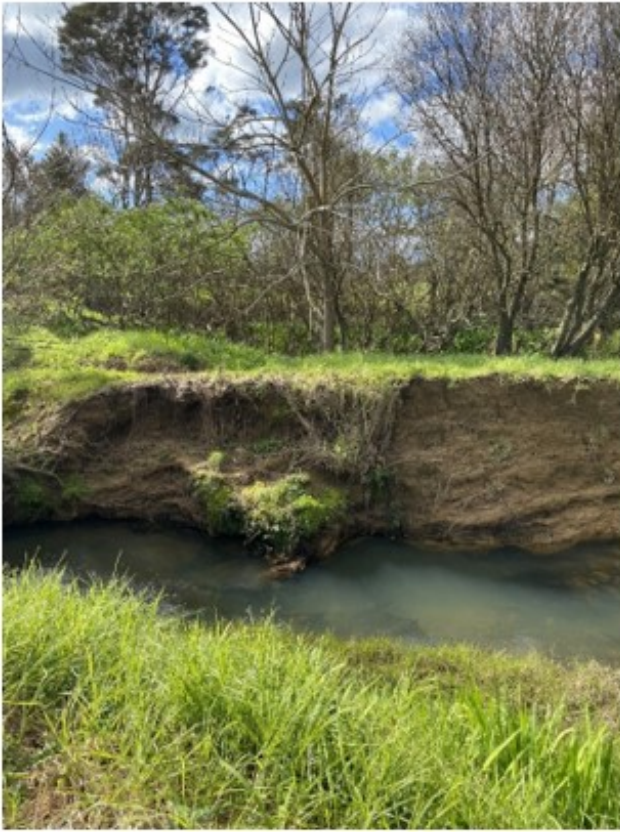
Figure 5. Erosion scars along TLB.

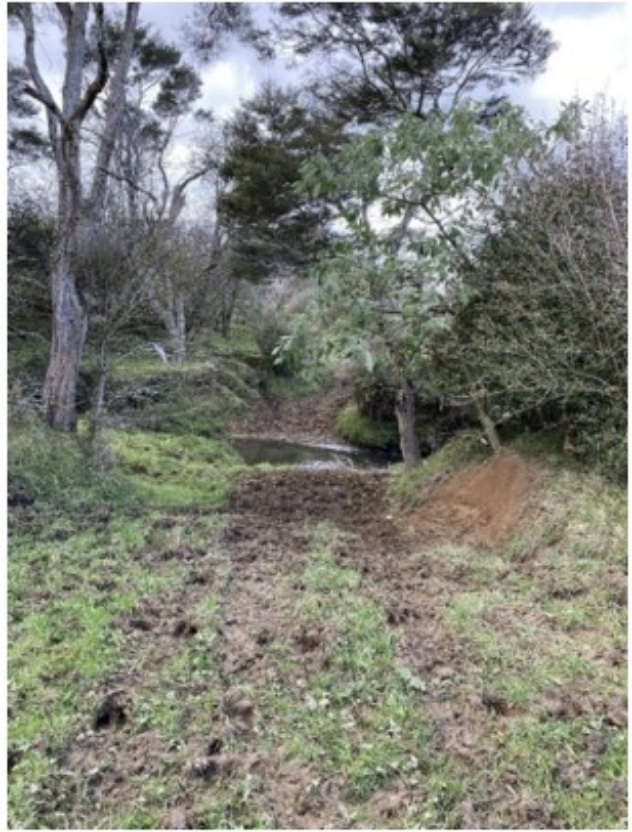
Figure 6. Stock accessway through the Huarahi Stream.

It is estimated that approximately 8,250 meters of fencing is required between the coast and Toft Road. It is recommended that 4 – 5 wire and post fencing is used to reduce debris collection and fencing damage during flood events whilst maintain stock exclusion. It is recommended that fencing is constructed around the planted riparian buffer to support the growth and resilience of the buffer. Additionally, stock access points should be limited and where completely necessary, access should be via bridges as opposed to through the stream.

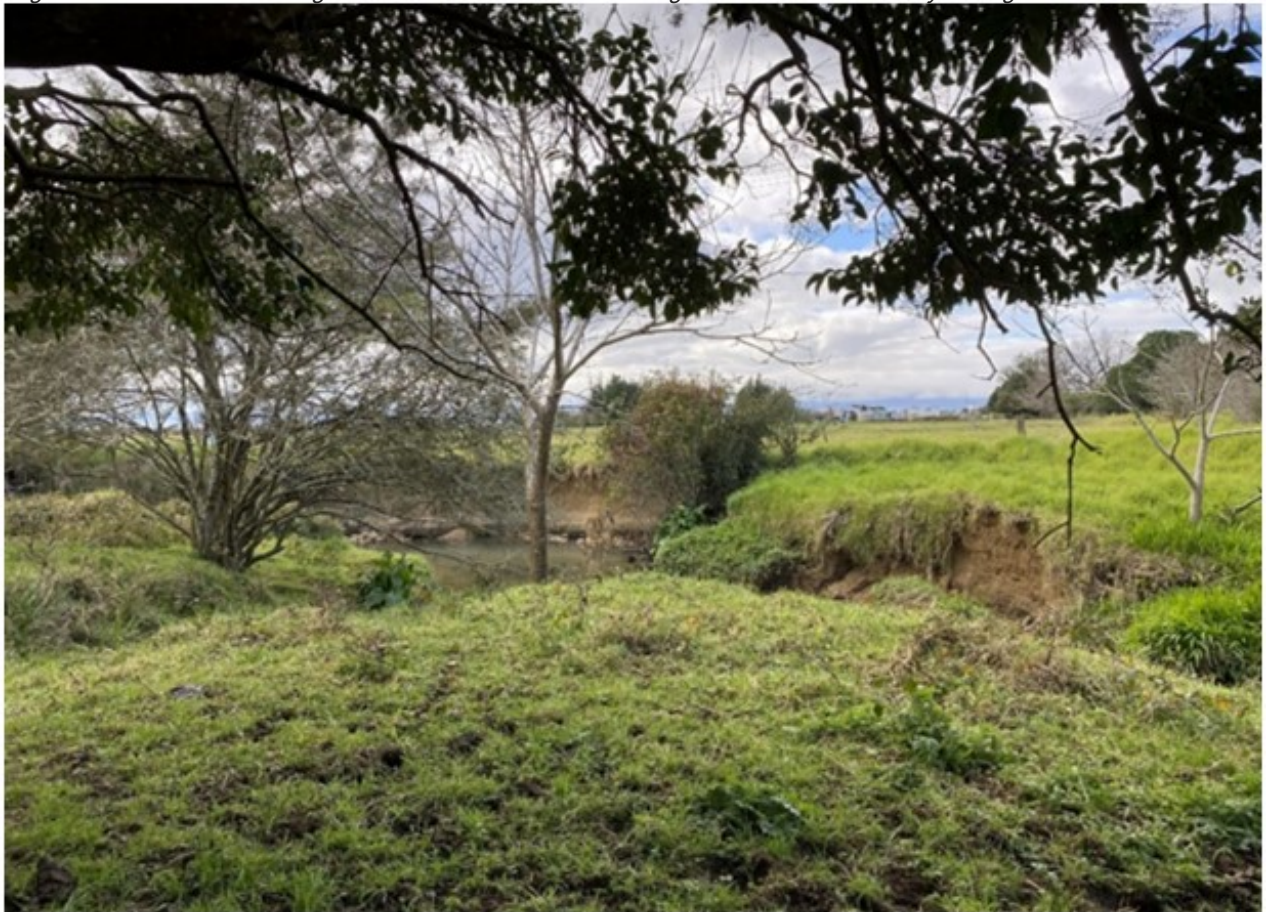
Figure 7. Bank scour and mass wasting along TRB.

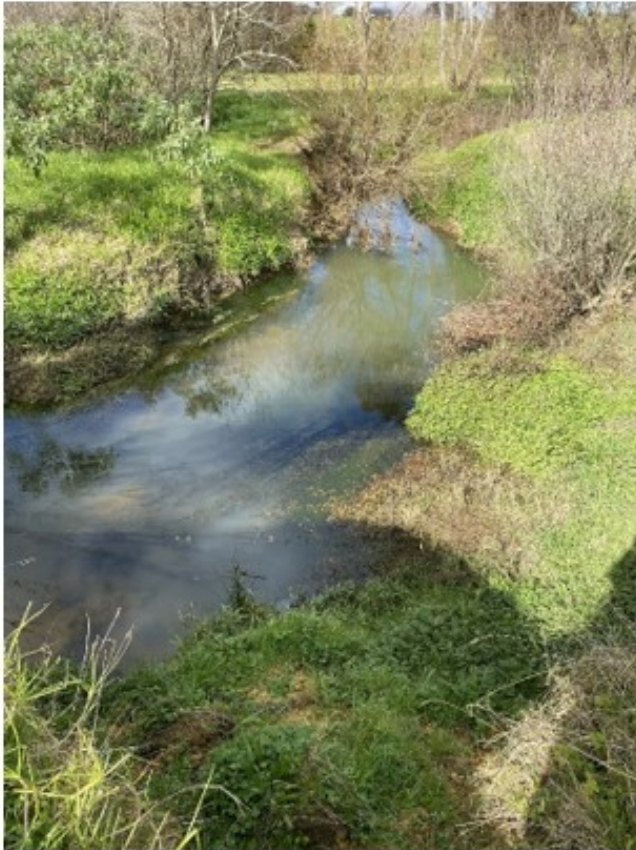
Figure 8. Crispy pondweed and other macrophytes in stream.

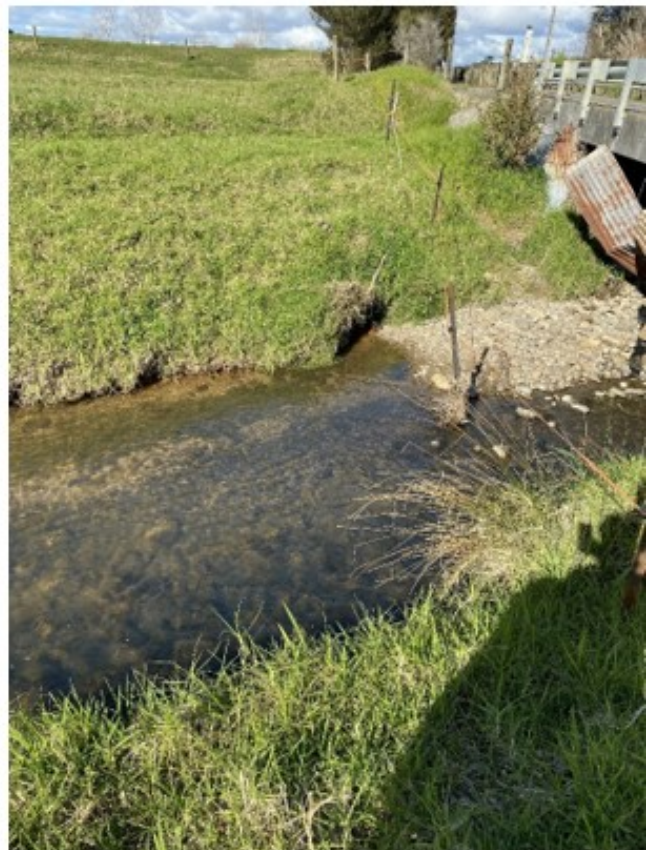
Figure 9. Green algae on streambed at Toft Road Bridge.

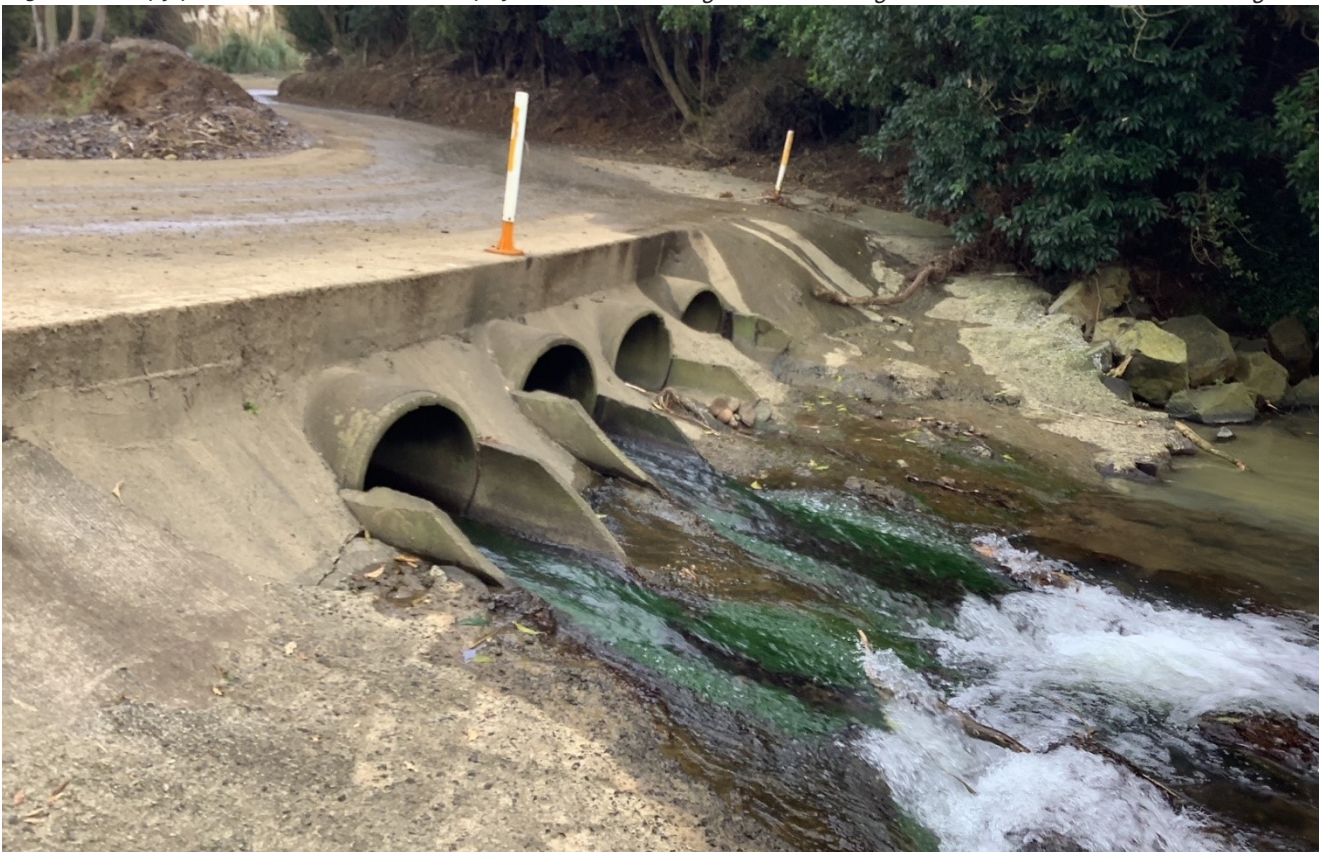
A series of culverts associated with a ford is located on Makaewa Road (upstream of Toft Road) which is likely to present a barrier to fish passage, particularly for poor climbing species due to accelerated water velocities. This is likely to be preventing the migration of fish species into the high-quality stream habitat upstream of the barrier.

Figure 10. Ford and culverts at Makaewa Road.

Fish passage barriers throughout the stream such as the ford present on Makaewa Road should be remedied to improve connectivity between the coast and high value stream habitat within the QEII block. Remediation of fish passage barriers can be undertaken according to the *New Zealand Freshwater Fish Passage Guidelines* (Franklin *et al*, 2022) with Regional Council support.
