Awa Matakana bank erosion and channel stability qualitative assessment

Short Report for Friends of Awa Matakanakana, A2E engagement

March 2024

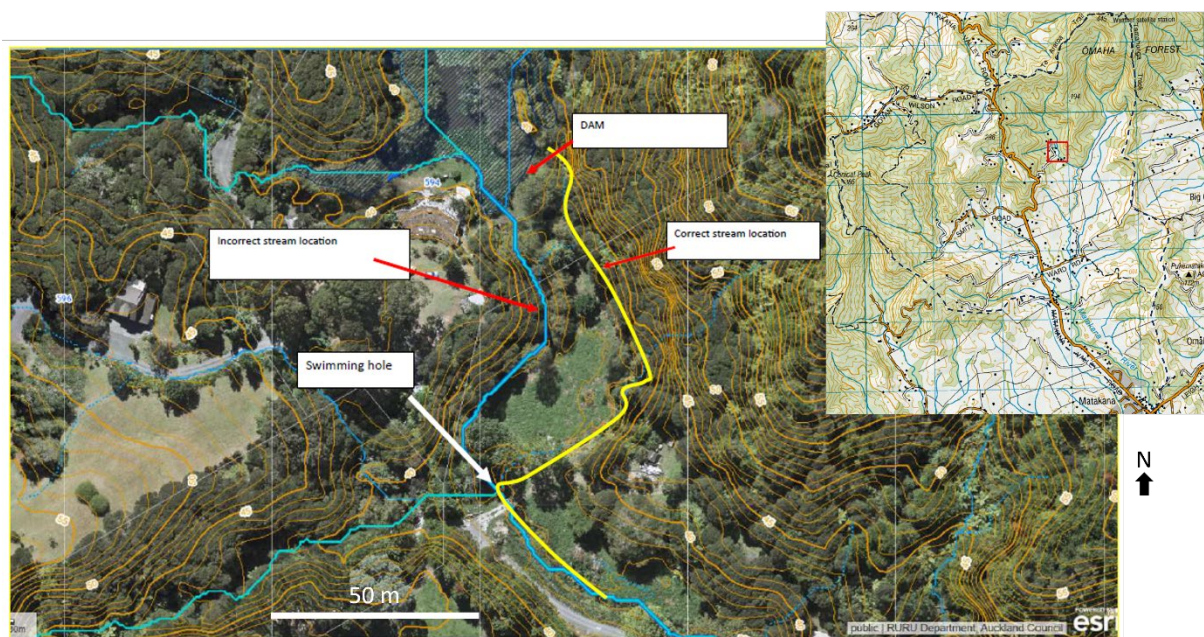
Figure 1. Reach of Awa Matakana tributary visited with FOAM on 19 January (yellow). The 'incorrect' stream location labels a former position of the channel. This reach continues to convey some flow, but the yellow line depicts the approximate position of the channel conveying the main flow at the time of the site visit. This channel was dug at an indeterminate date in the past to drain a wetland area, which is now paddock (green area between yellow and blue lines in aerial photograph). Topographic map extract (1 km blue grid squares for scale) shows site location (red box overlay) in the context of the catchment above Matakana township (outlined with dashed line). Annotated aerial image supplied by FOAM, note correct stream line below swimming hole follows blue line.
